TEST REPORT

: BCT-170210-00015

FIRE TESTING OF MATERIALS, COMPONENTS AND ELEMENTS USED IN BUILDINGS SANS 10177 P 2- 2005 "FIRE RESITANCE TEST FOR BUILDING ELEMENTS"

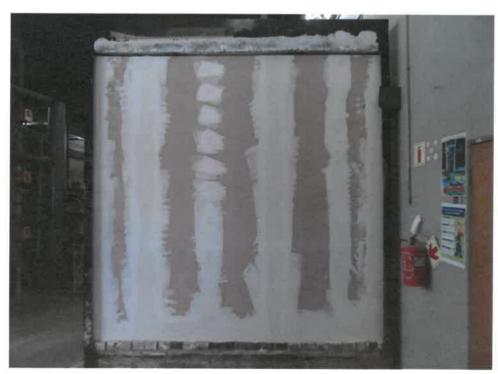
No1: Exposed side of the panel prior to test

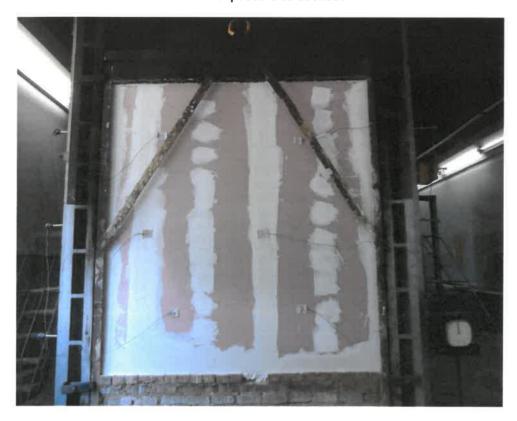
No 2: Unexposed side at onset

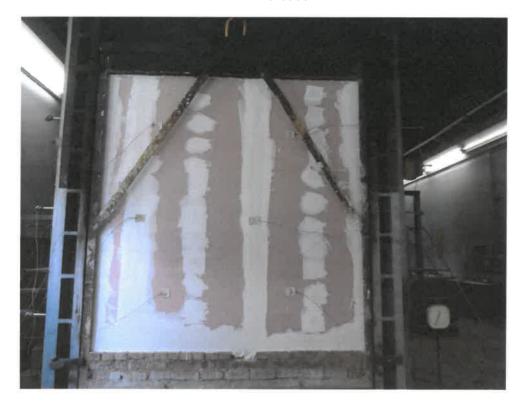
No 3: Panel at 30 min

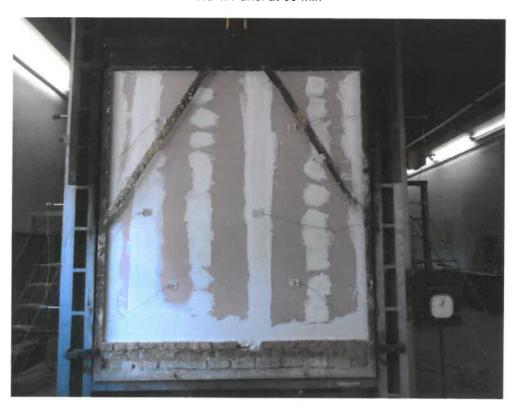
No 4: Panel at 60 min

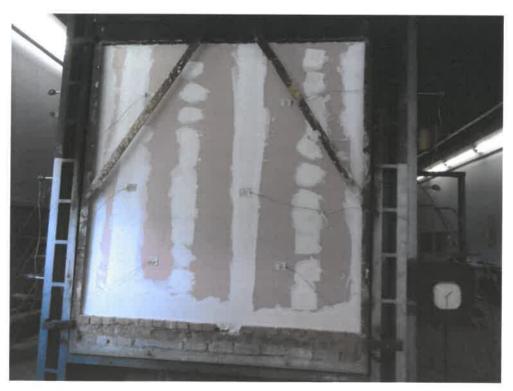
No 5: Panel at 90 min

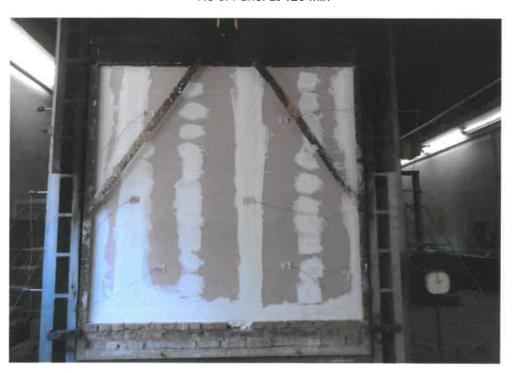
No 6: Panel at 120 min

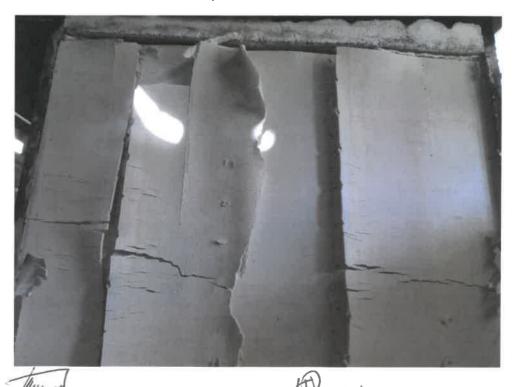
No 7: Exposed face after test.
