TITLE : Report on the Large-scale Fire Resistance properties of the **Capco 60 minutes Fire Rated Ceiling (Insulated)**

REQUESTED BY : **Capco (Pty) Ltd**
PO Box 4203
Riverhorse Valley East
DURBAN
4017

CONTRACT No : FTC 23/212 (a)

DATE : 01 December 2023

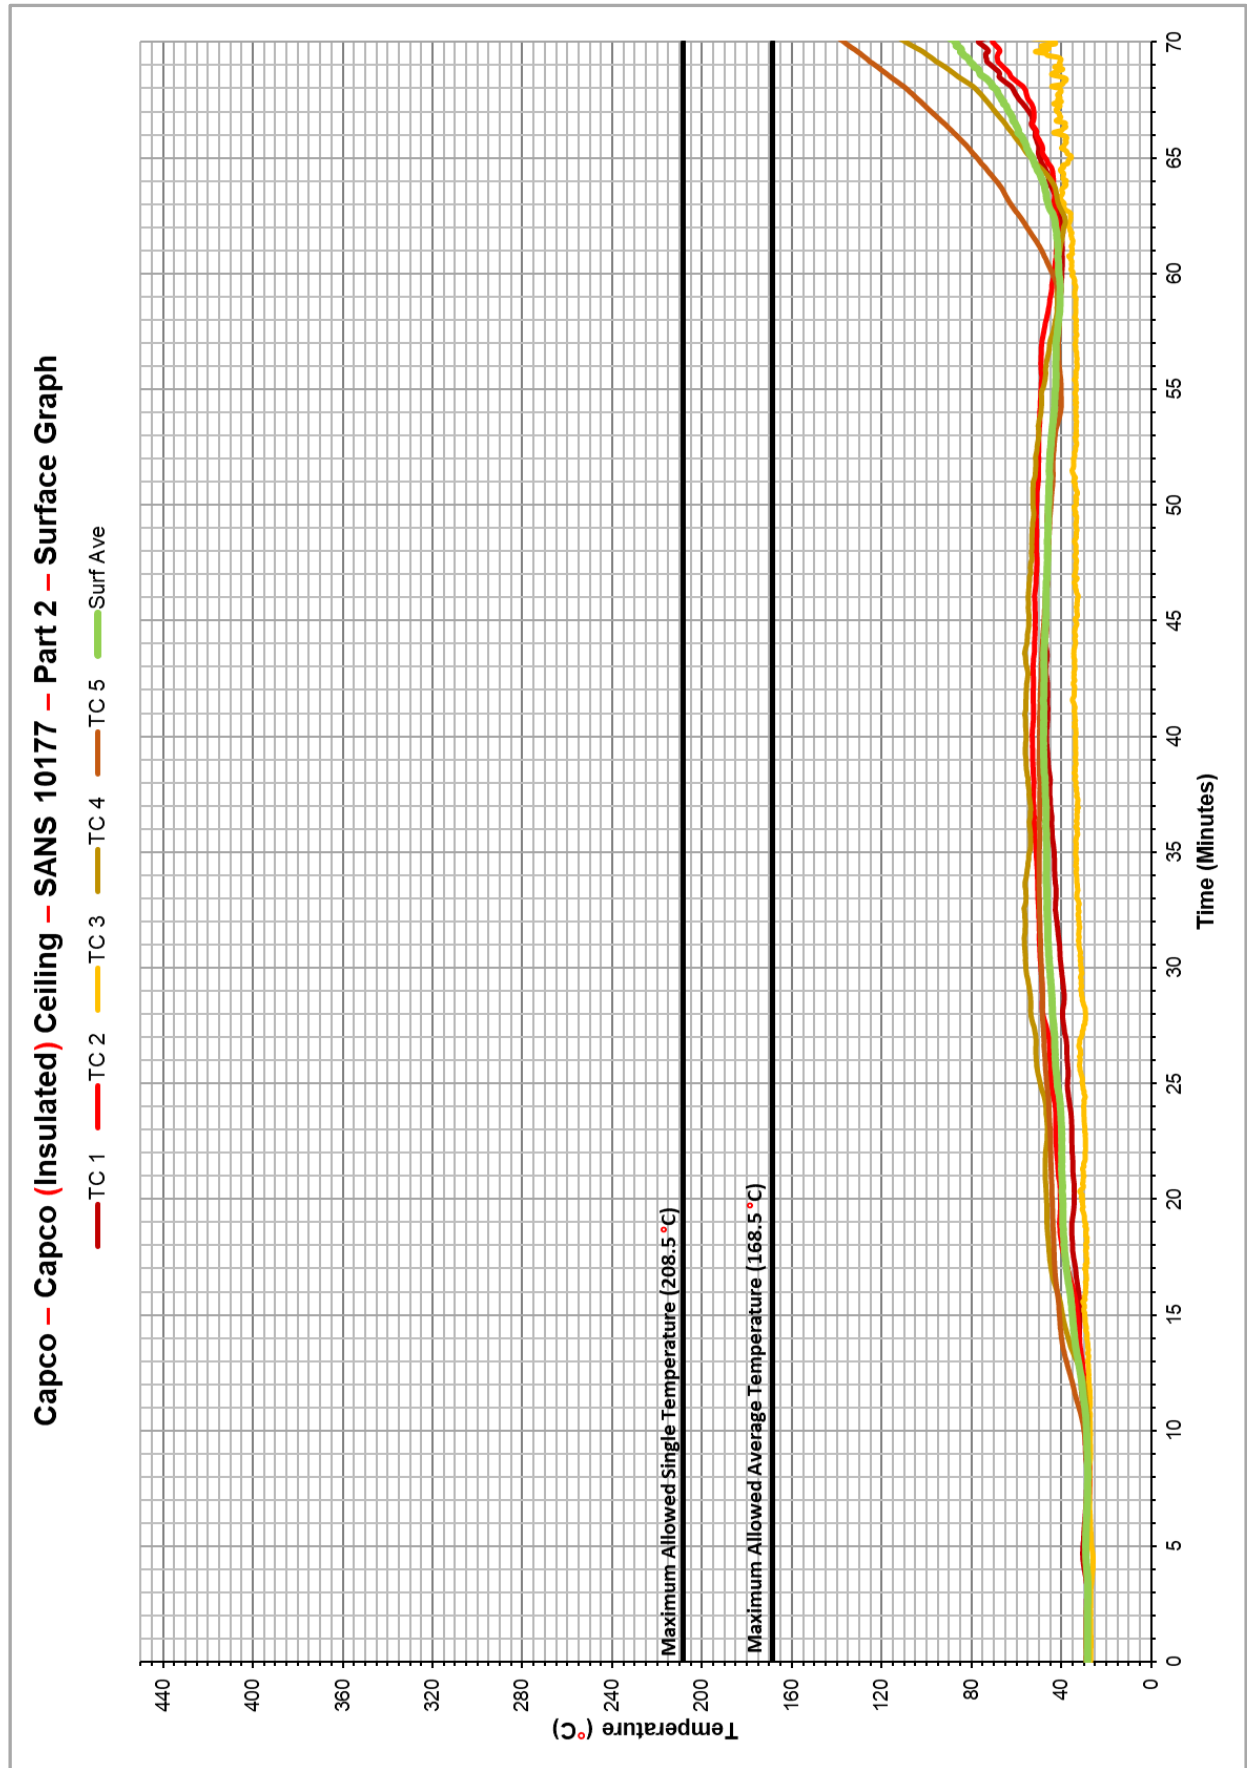
Figure 3.2: Temperatures recorded on the surface of the specimen

**Insulation (I):** None of the thermocouples reached their maximum allowable temperatures during the test duration.
Insulation satisfied for 60 minutes

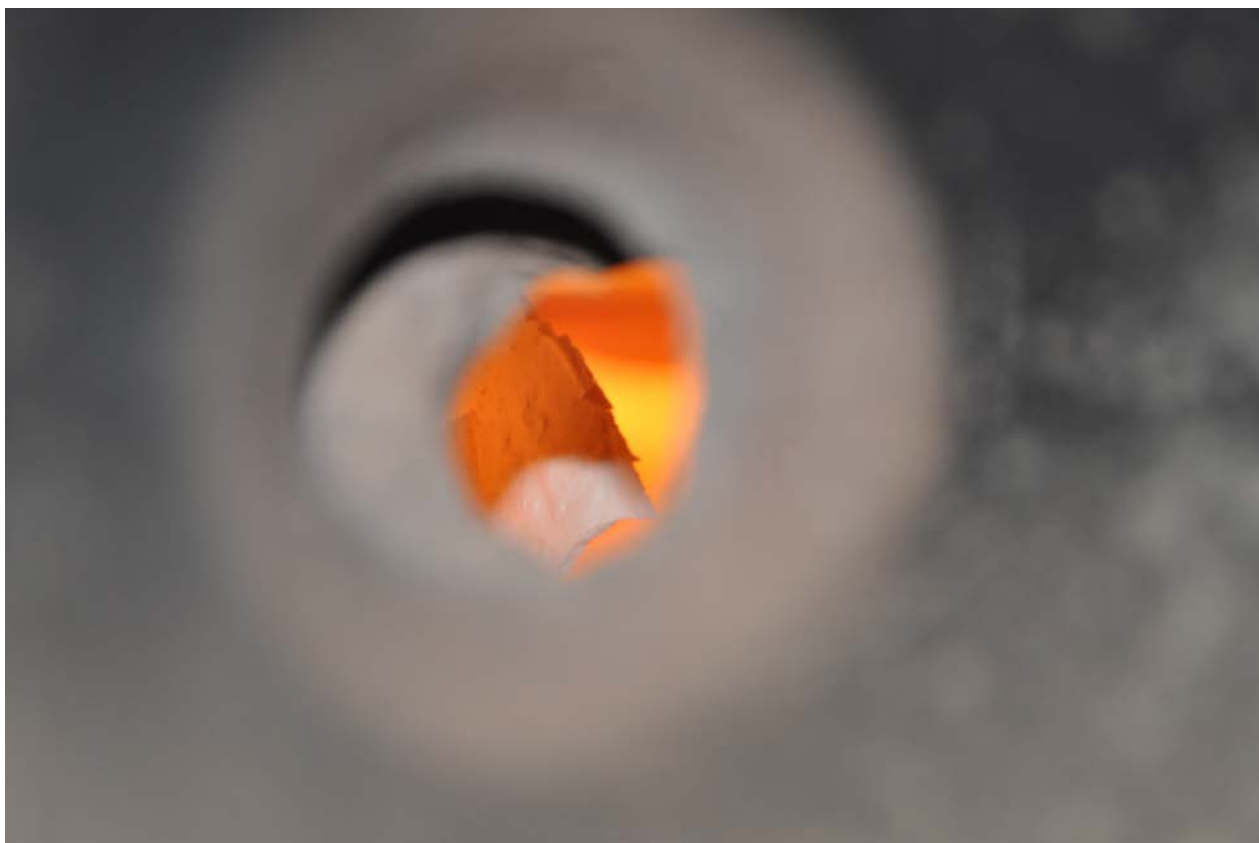
00:18:40	Smoke coming through insulation in the middle
00:19:20	First layer of boards starting to sag
00:36:00	Density of the smoke released increased
00:41:00	Pieces flaking off the first layer of boards

Figure 3.3: First layer of boards sagging

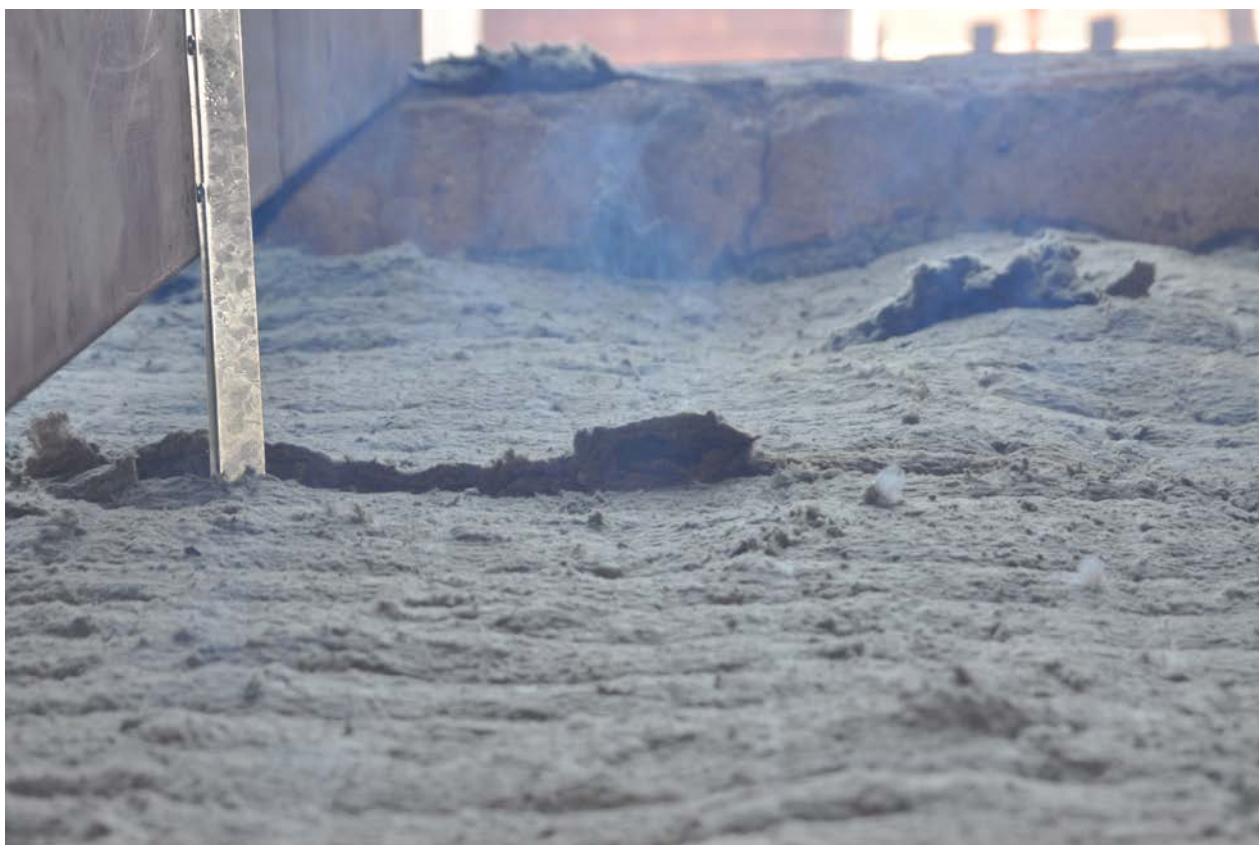
Figure 3.4: Smoke release density increase

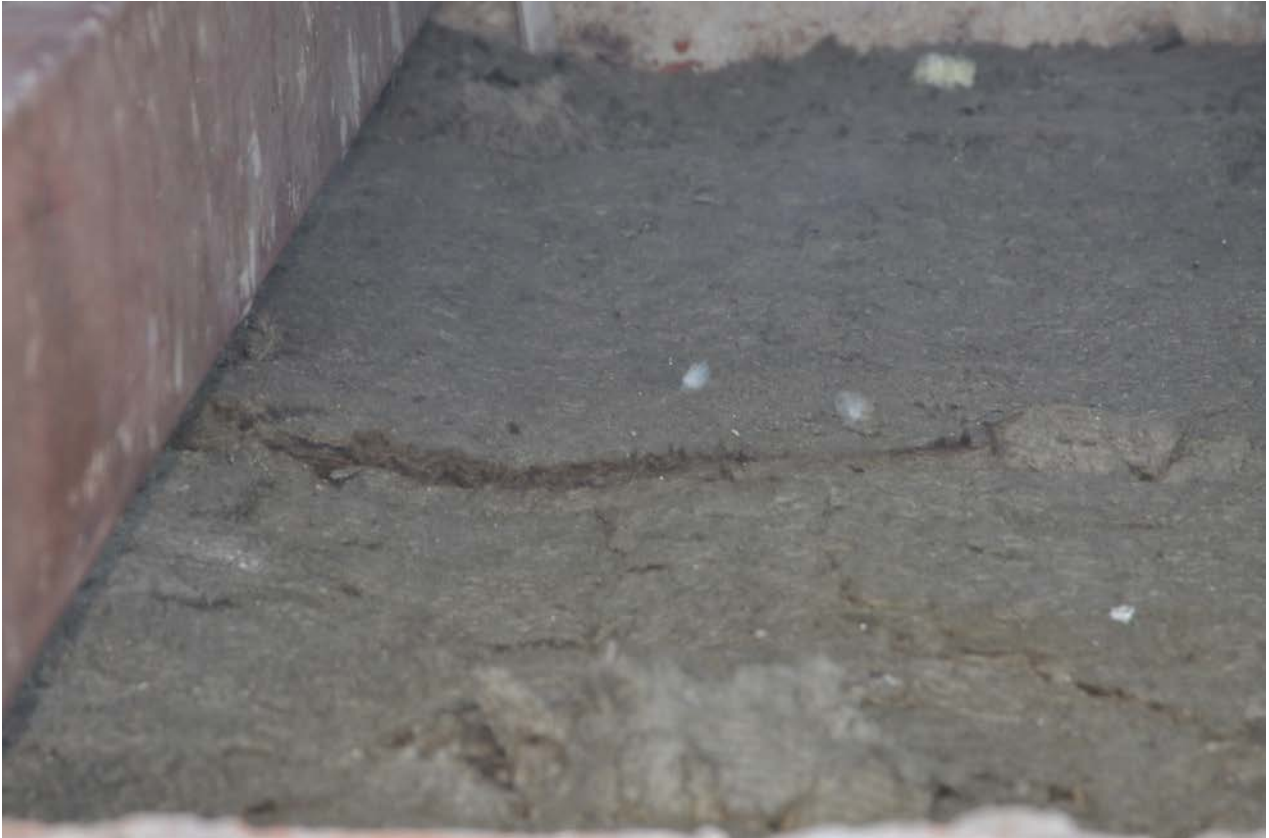
00:52:40	Insulation darkening on joint
00:55:20	Significant smoke release near TC 1
00:56:00	Board joints starting to open (exposed side)
00:59:00	Board charring on right perimeter and edging buckling (uninsulated section)

Figure 3.5: Insulation darkening on joint

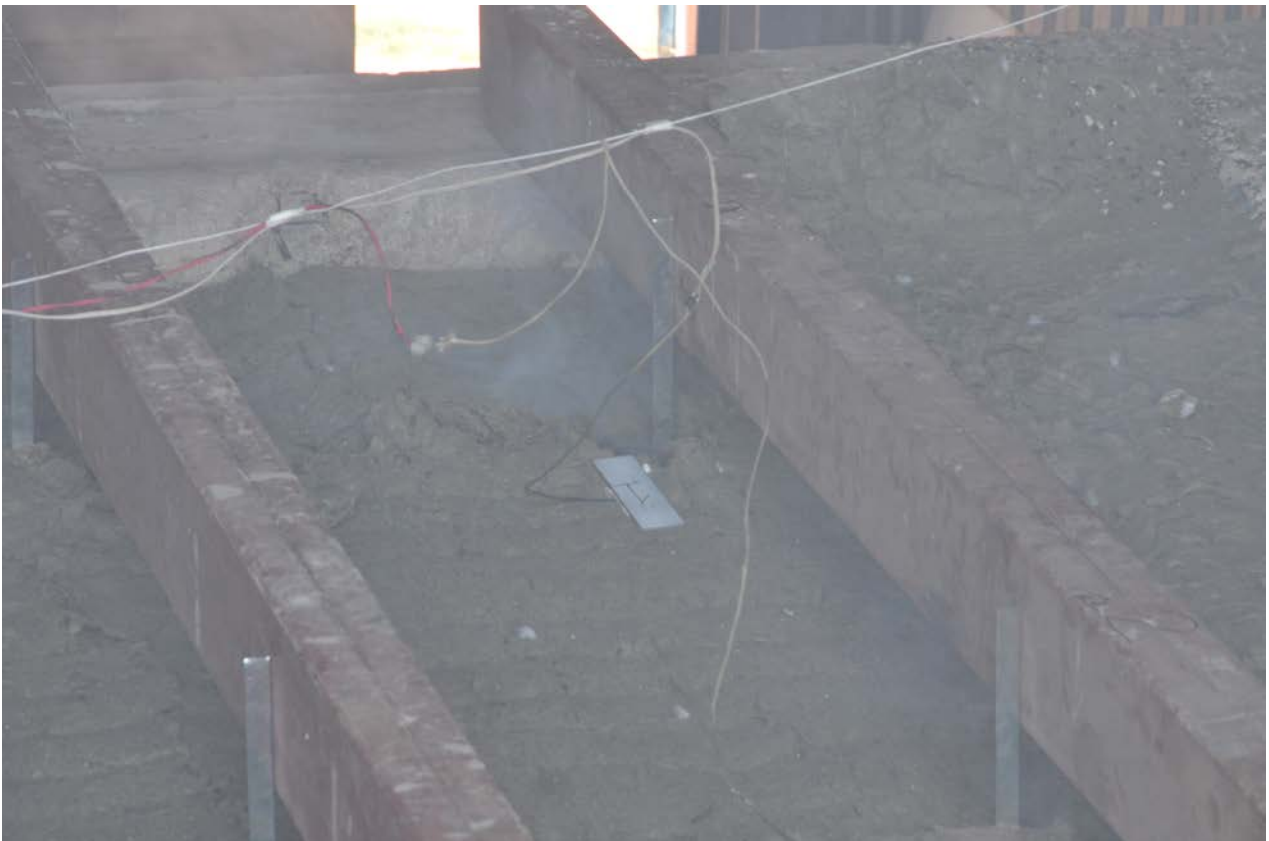
Figure 3.6: Significant smoke release near TC 1

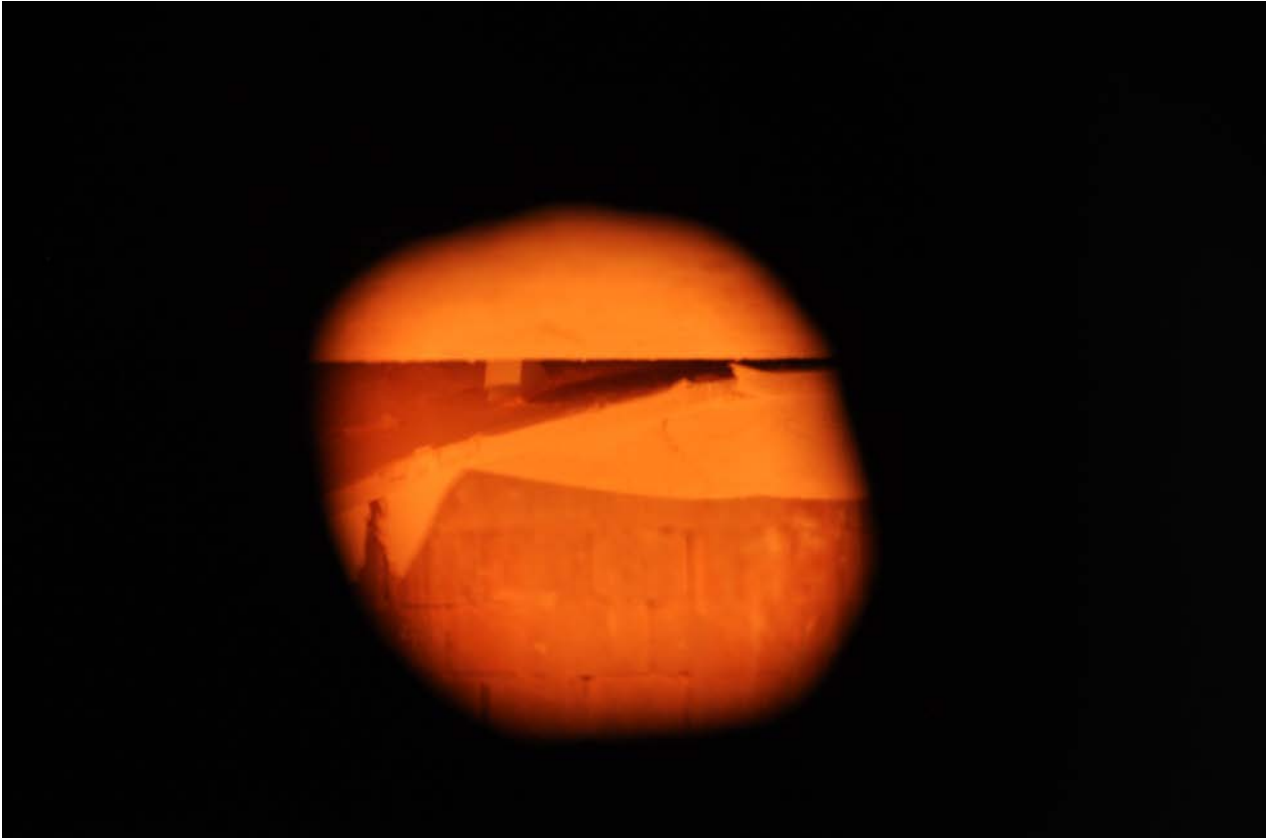
01:00:00	First layer of boards sagging significantly (insulated section)
01:03:20	System sagging near back perimeter and glowing under insulation (insulated section)

Figure 3.7: First layer of boards sagging significantly

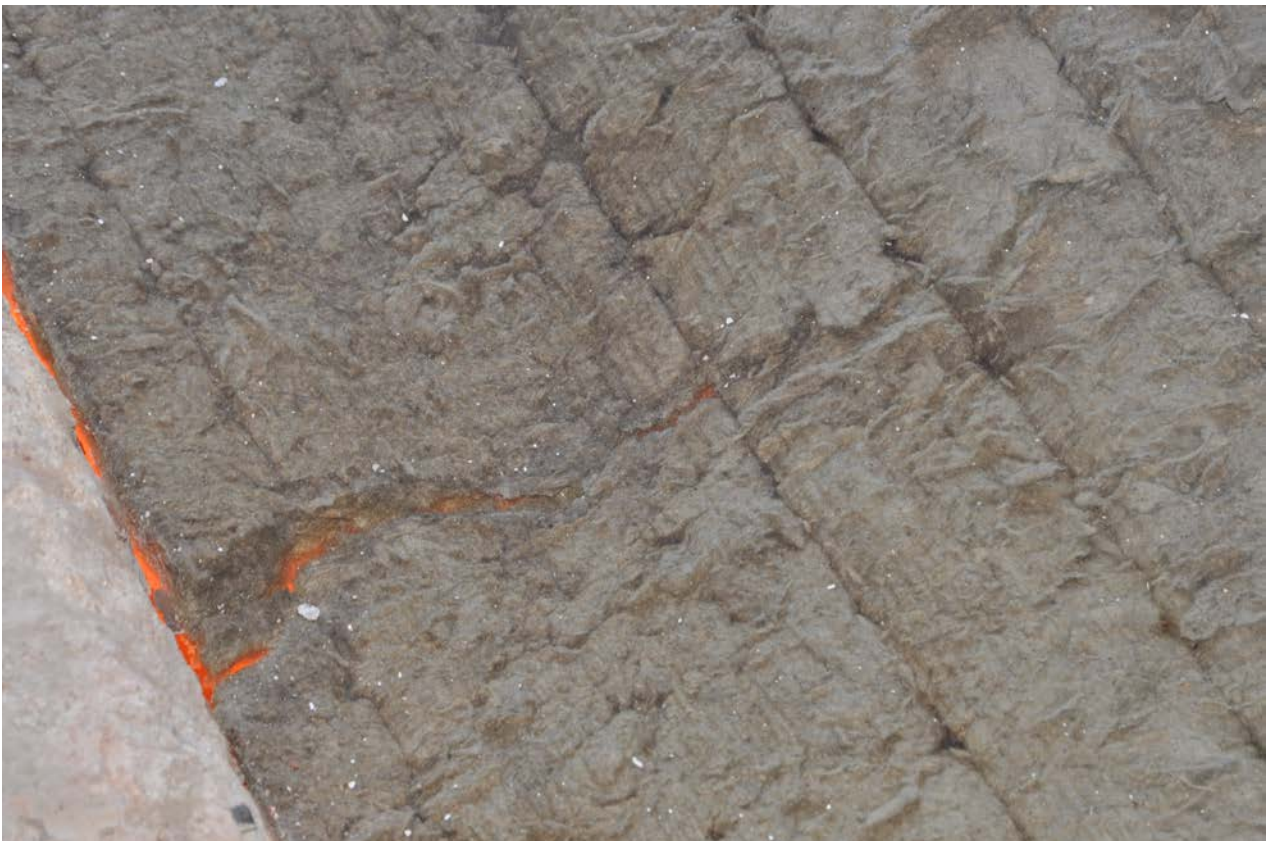
Figure 3.8: Glowing observed through insulation

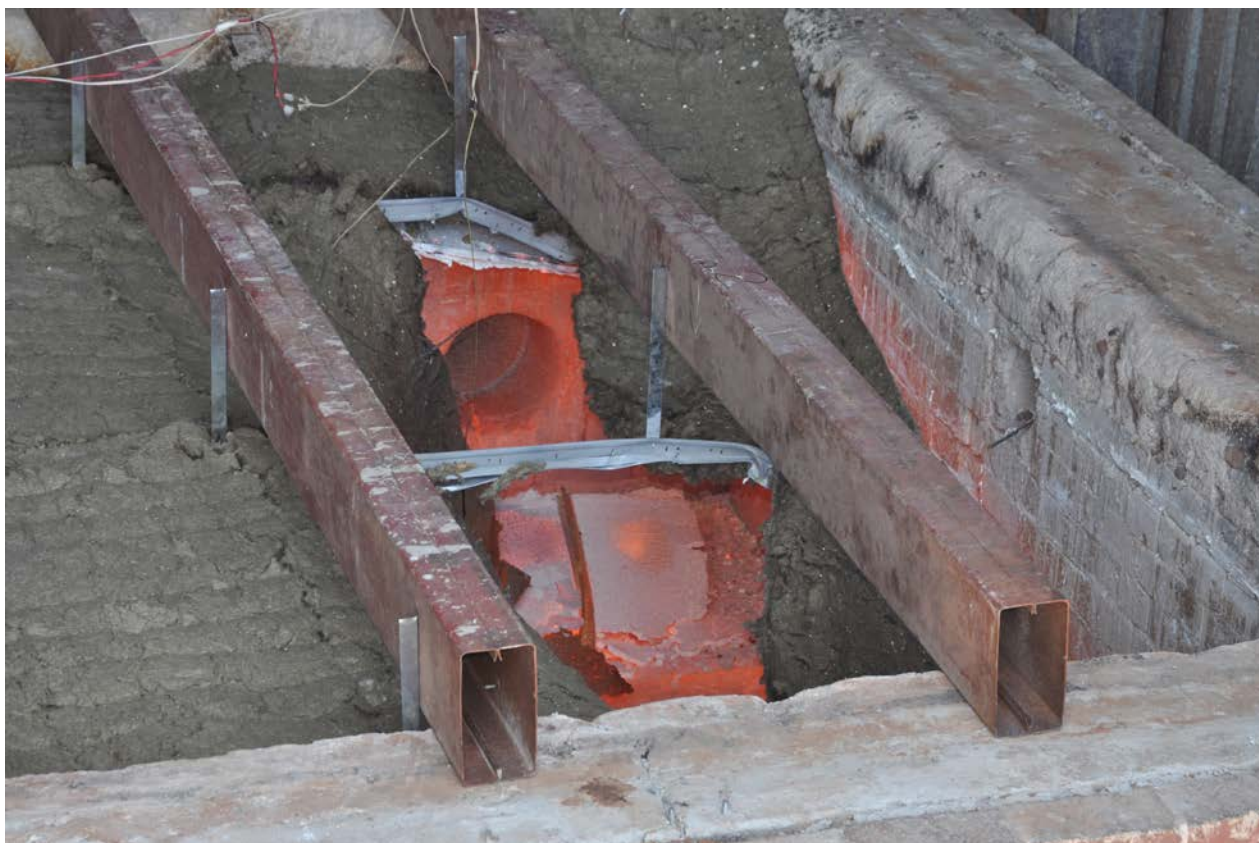
01:07:00	Insulation sagging significantly at back perimeter (insulated section)
01:09:55	System collapsed near back perimeter (insulated section) » Fails Stability

Figure 3.9: System collapsed near back perimeter

**Stability (R):** The specimen collapsed after 60 minutes.
Stability satisfied for 60 minutes
-
