FIRELAB

TITLE : Report on the Large-scale Fire Resistance properties of the **60 minutes Fire Rated Ceiling (Uninsulated)**

REQUESTED BY : **Capco (Pty) Ltd**
PO Box 4203
Riverhorse Valley East
DURBAN
4017

DATE : 01 December 2023

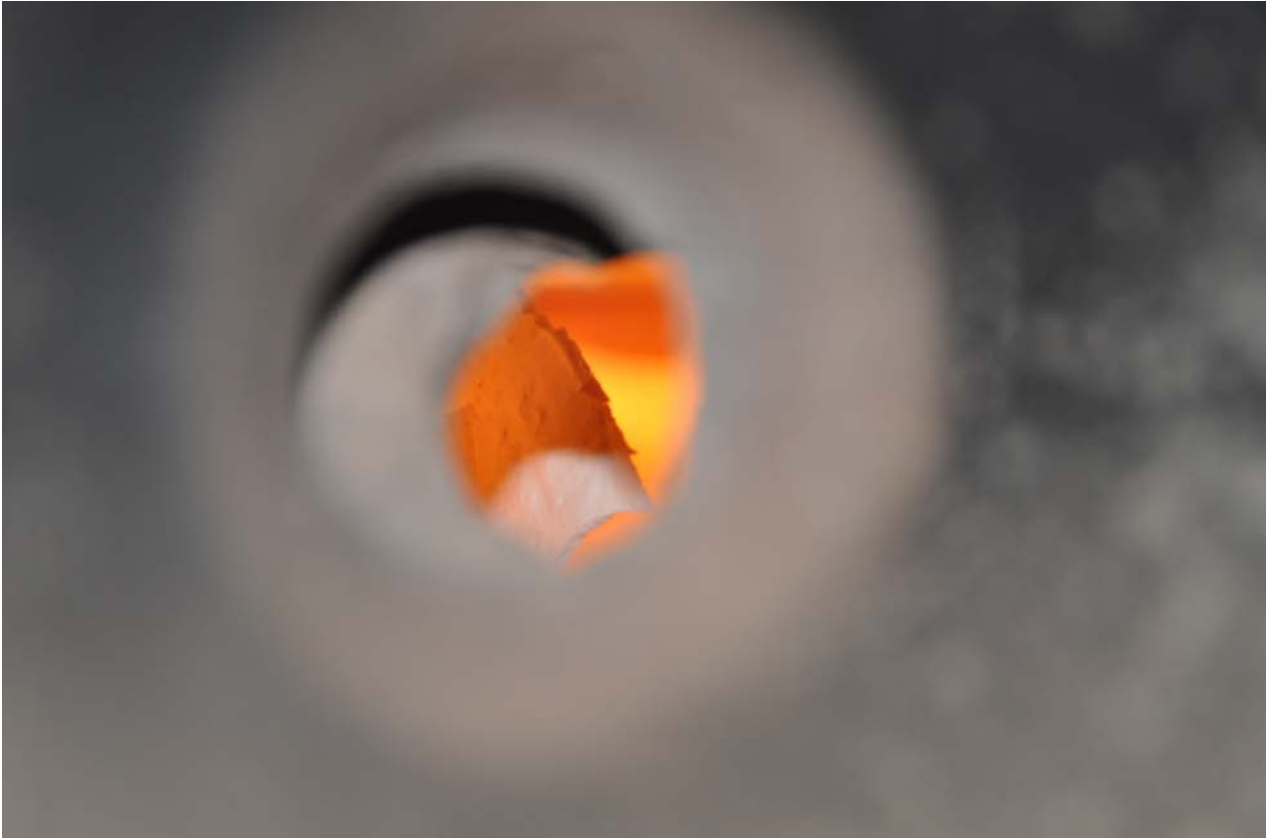
00:18:40	Smoke coming through insulation in the middle
00:19:20	First layer of boards starting to sag
00:36:00	Density of smoke release increased
00:41:00	Pieces flaking off the first layer of boards

Figure 3.3: First layer of boards sagging

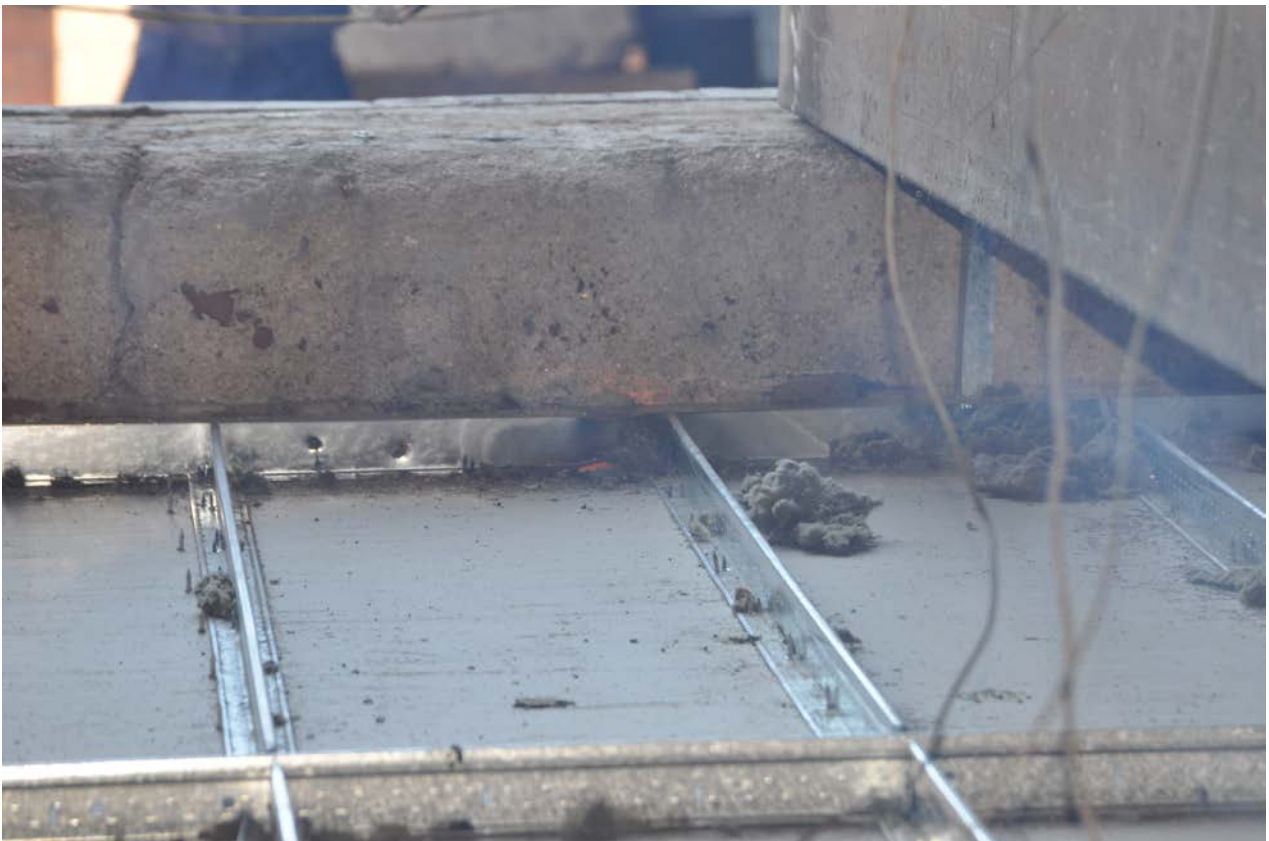
Figure 3.4: Glowing observed between board and steel

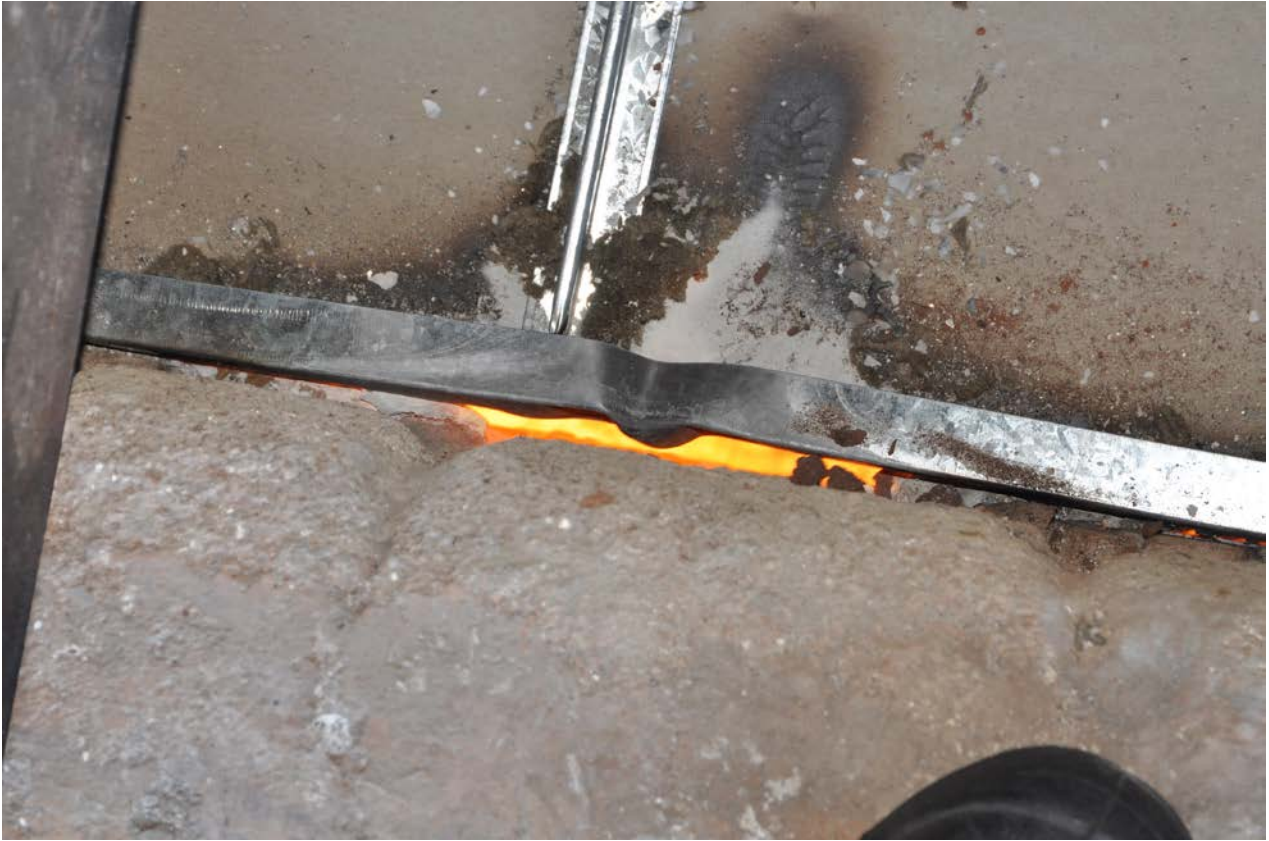
00:52:40	Insulation darkening on joint
00:55:20	Significant smoke release near TC 1
00:56:00	Board joints starting to open (exposed side)
00:59:00	Board charring on right perimeter and edging buckling (uninsulated section)

Figure 3.5: Edging buckling and board charring

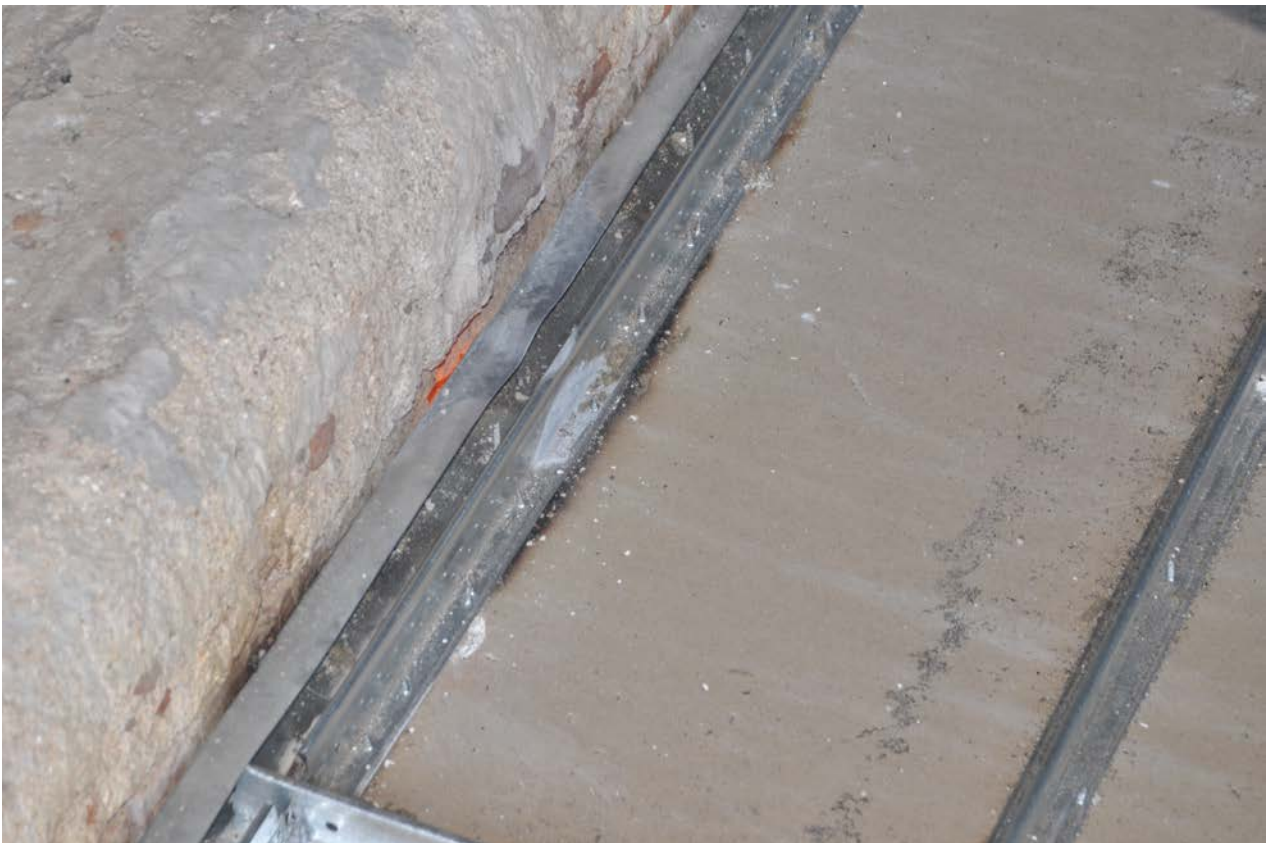
Figure 3.6: Charring at front perimeter

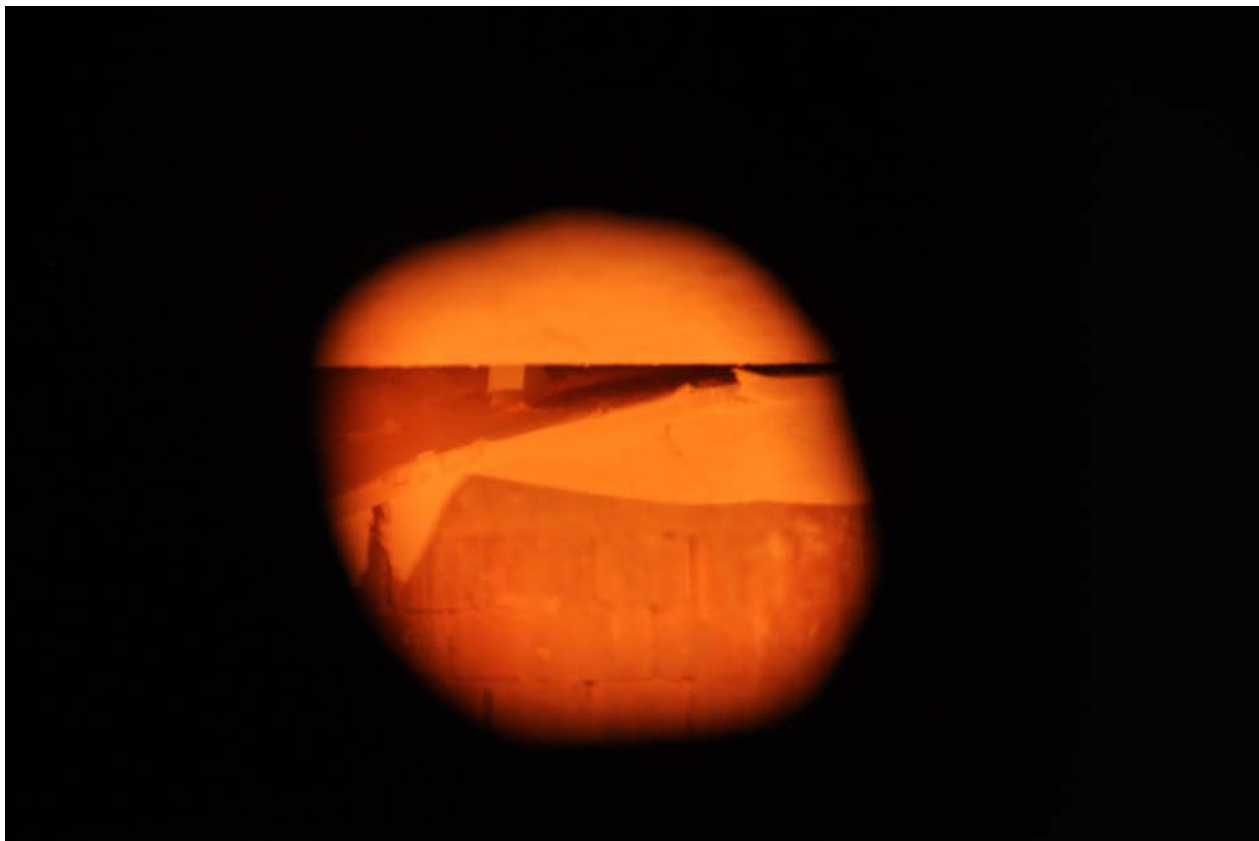
01:00:00	First layer of boards sagging significantly (insulated section)
01:03:20	System sagging near back perimeter and glowing under insulation (insulated section)

Figure 3.7: First layer of boards sagging significantly
