FIRELAB

TITLE : Report on the Large-scale Fire Resistance Properties of the **CAPCO FireShield Ceiling System**

CONTRACT No : FTC 20/003

DATE : 15 September 2020

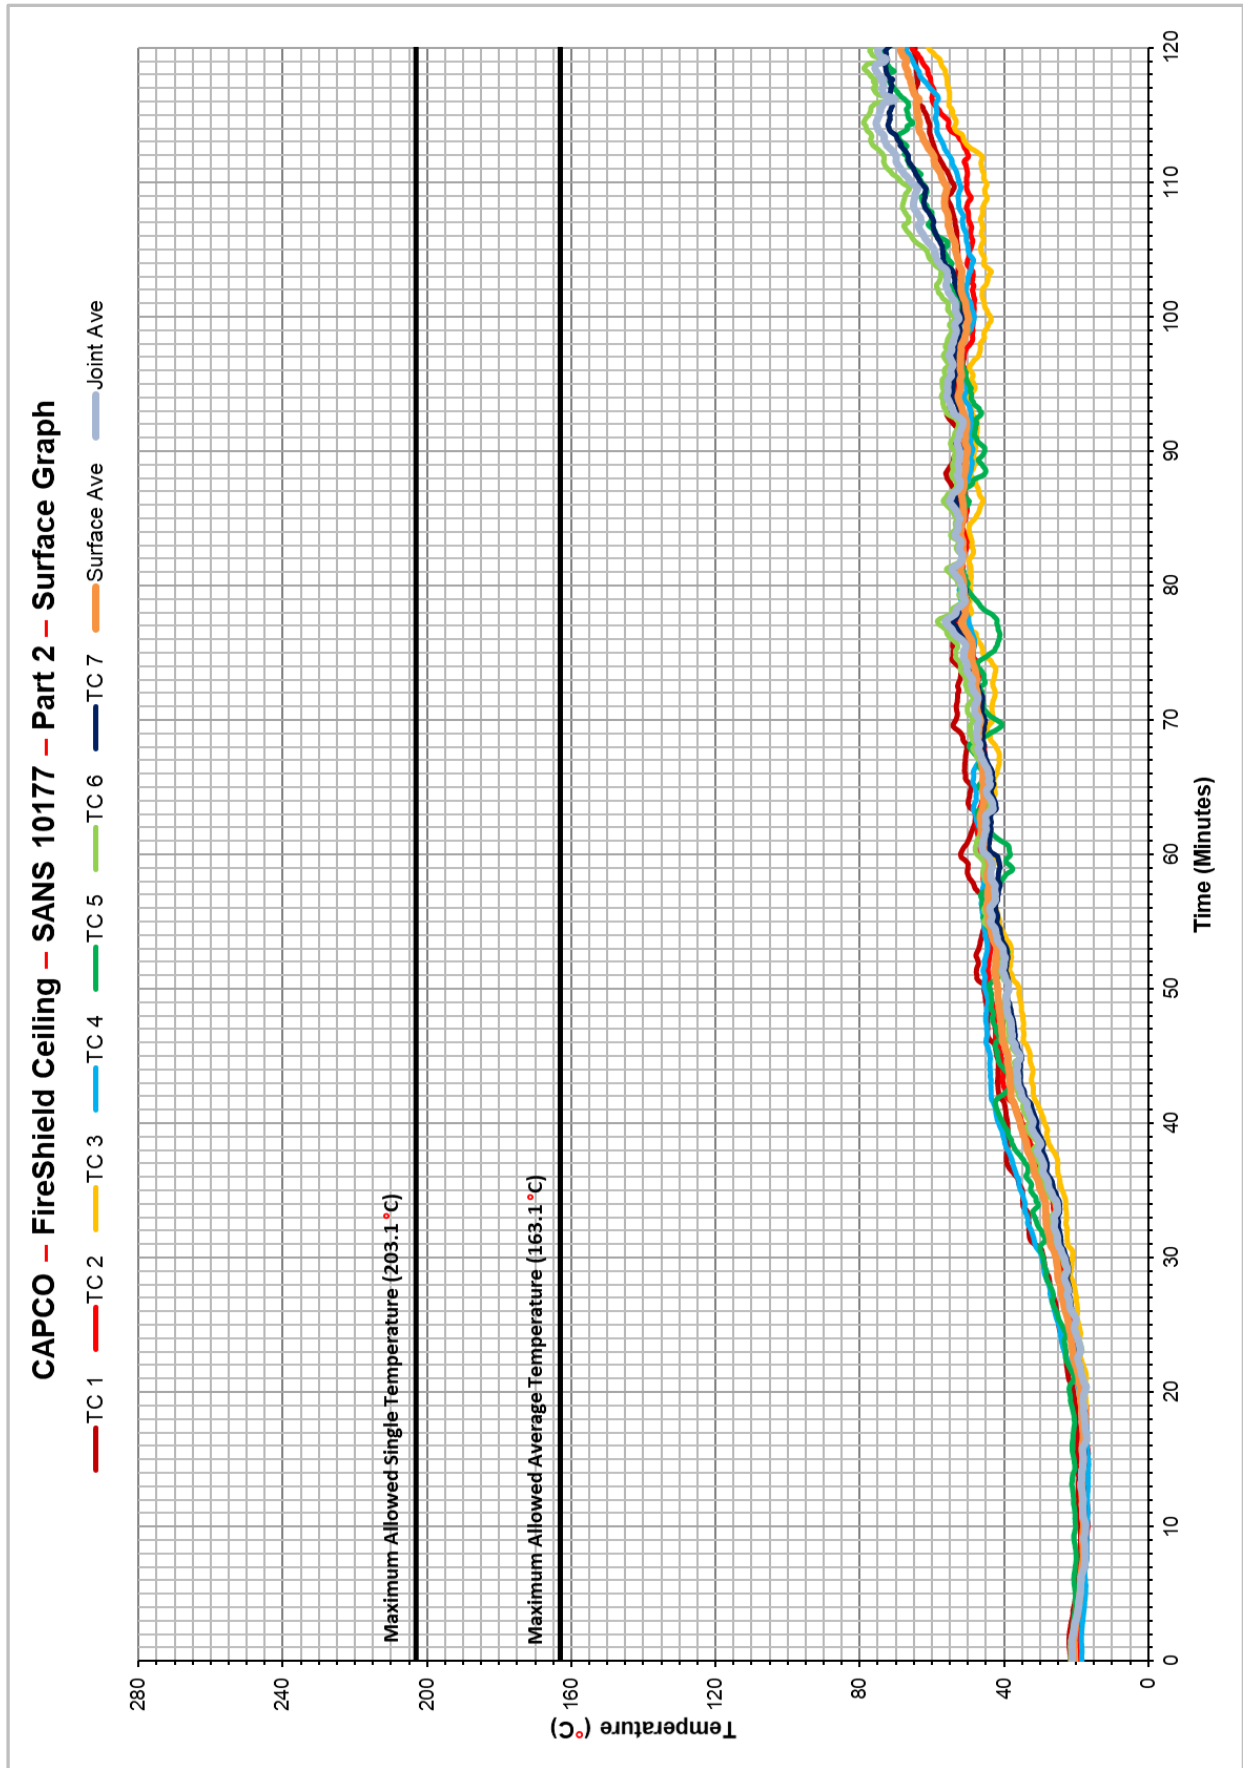
Figure 3.2: Temperatures recorded on the surface of the specimen

**Insulation (I):** TC 6 reached the maximum allowed single temperature after 2 hours 6 minutes and 30 seconds.
Insulation satisfied for 120 minutes

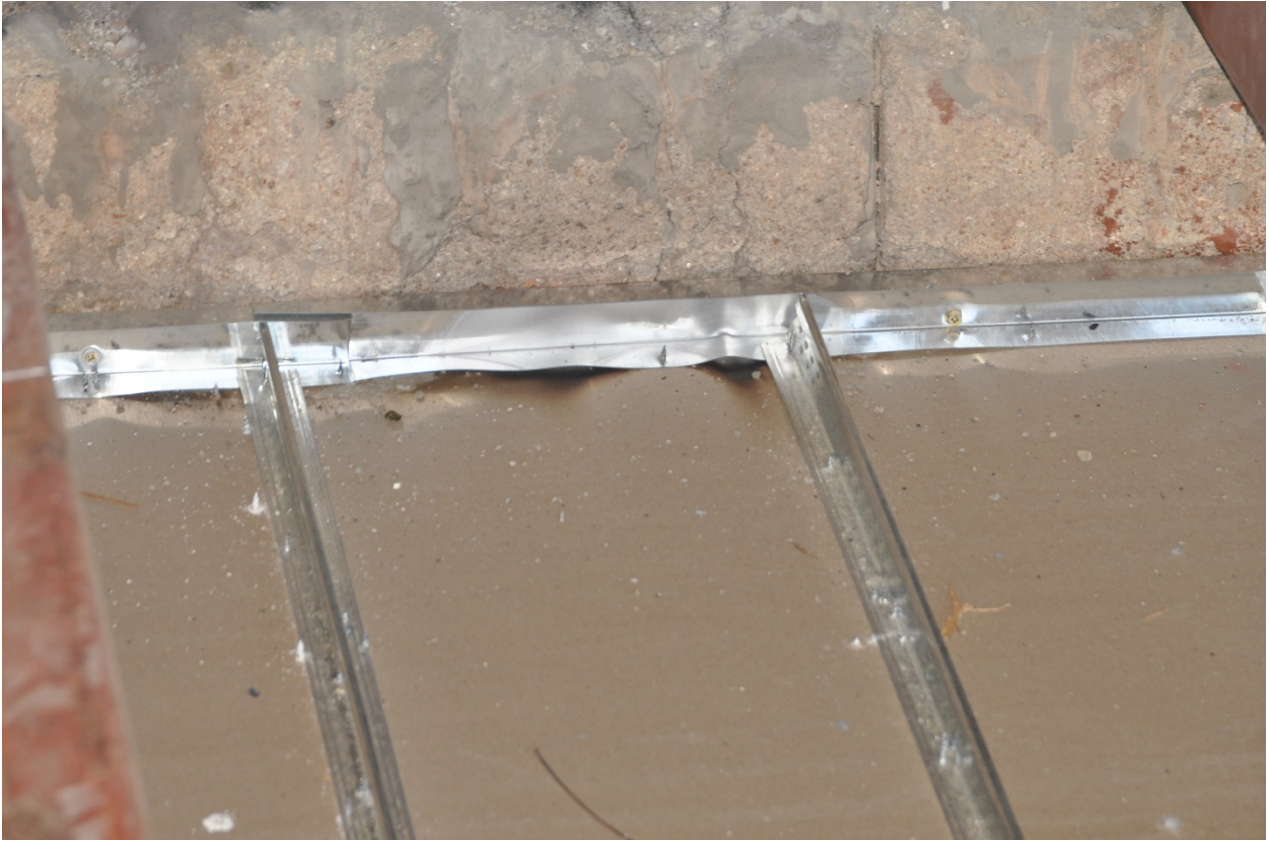
Note(s): The peripheral cracking was caused by viewports in the furnace walls, which would not be present in an installation in practice. Thus, the peripheral cracking can be disregarded

Figure 3.3: Charring and slight buckling of the perimeter fixing

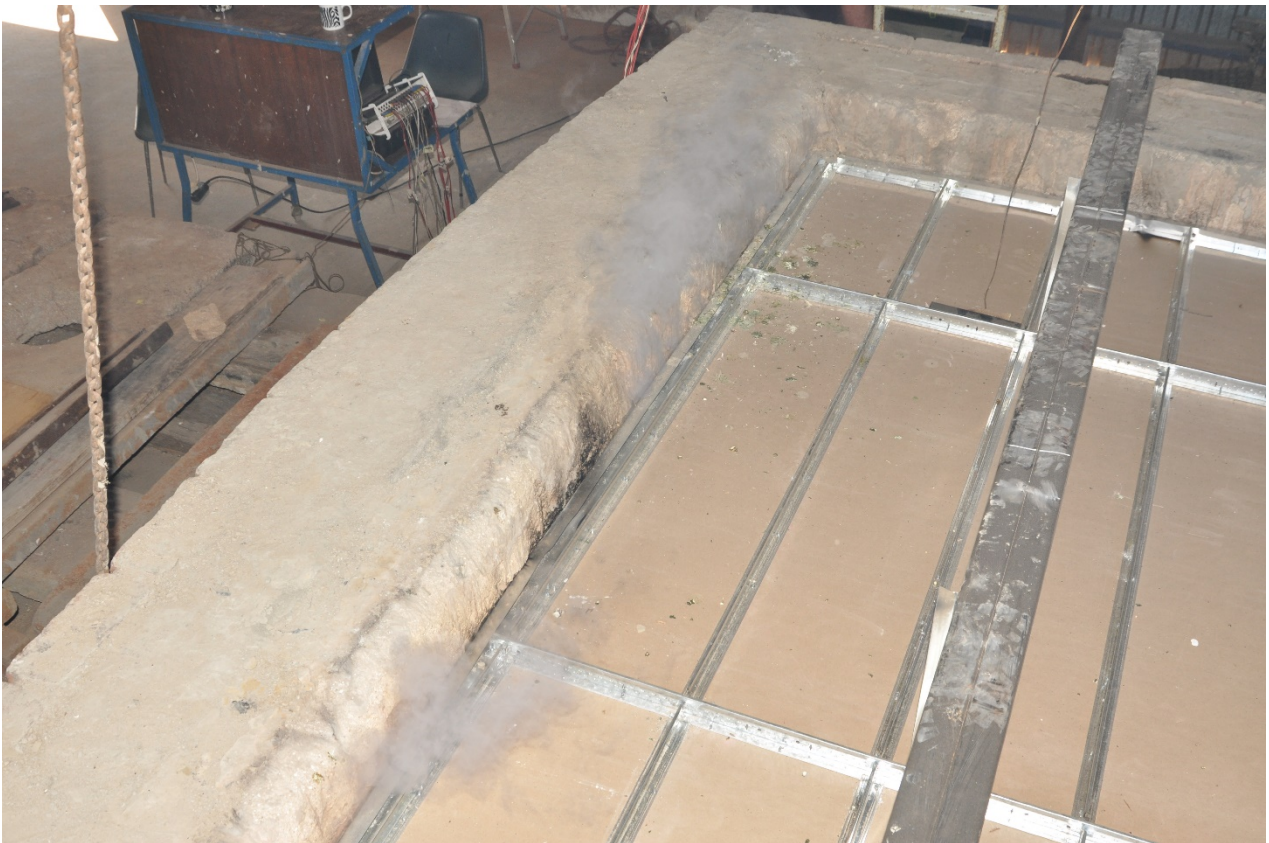
TIME (hh:mm:ss)	DESCRIPTION
00:00:00	– Test Started –
00:07:40	Smoke release on the middle of the right perimeter
00:08:20	Steam release on the front perimeter

Figure 3.4: Smoke release on the perimeter

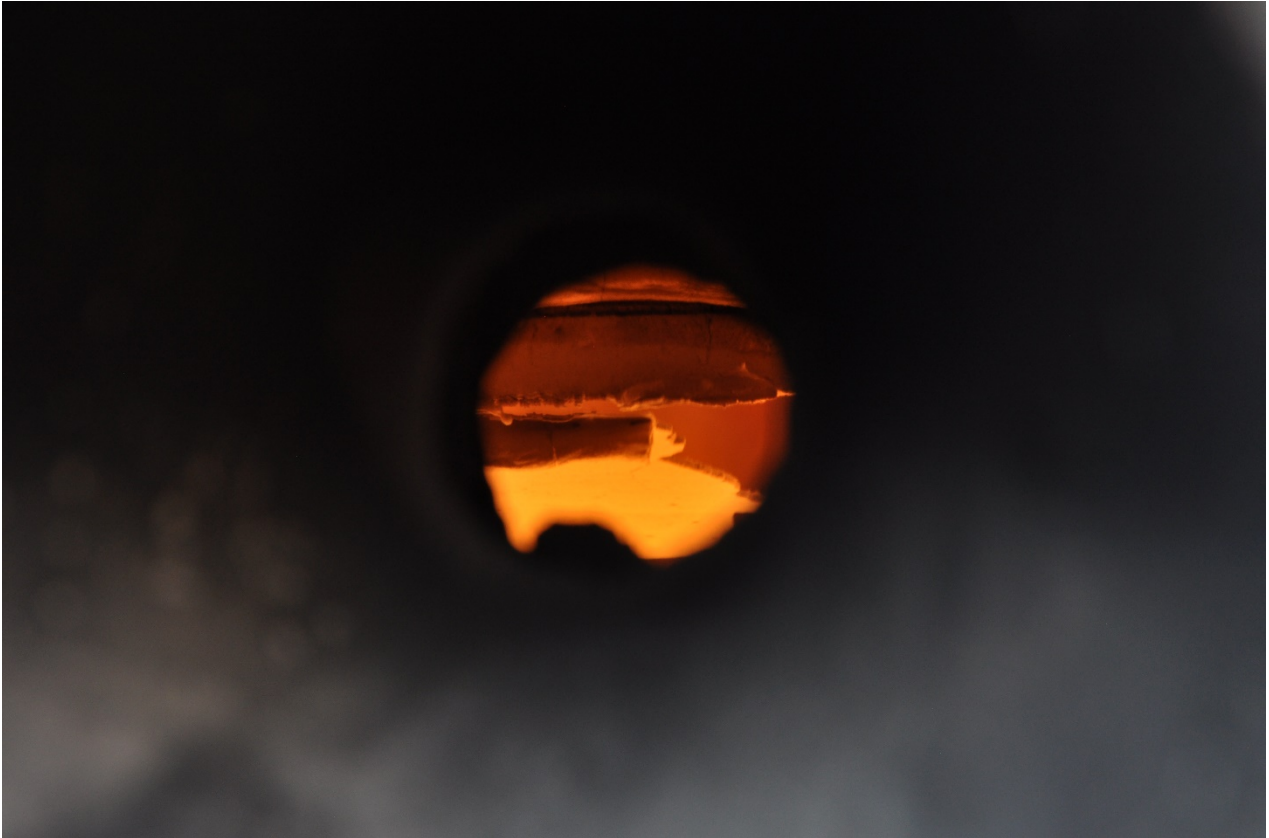
00:10:35	Charring on the smoke release areas
00:33:20	Pin-hole forming in the board between TC 4 & 5
00:40:00	Pin-hole forming in the board behind TC 3
01:02:30	First layer of the boards is starting to collapse

01:31:30	Smoke release increase on the right joint
01:36:30	Smoke release along the lateral joint on the right
01:40:00	Second layer of boards dropping off and draping

Figure 3.5: Bottom board fragmenting (mid-section of specimen)

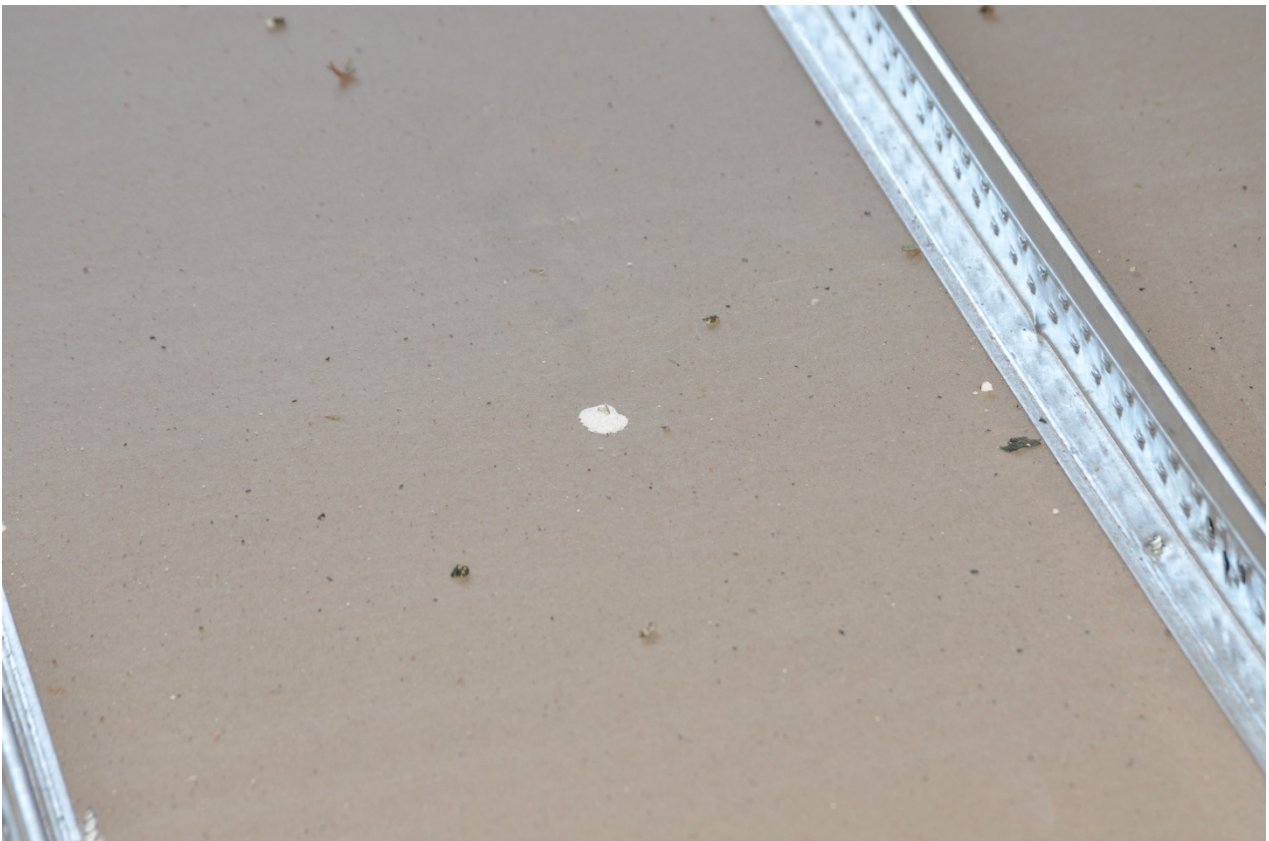
Figure 3.6: Pin hole formed in the specimen

**Integrity (E):** No significant straight through gaps or flaming occurred. There were small pin holes and small cracks observed, but was within allowable limits.
Integrity satisfied for 120 minutes
-

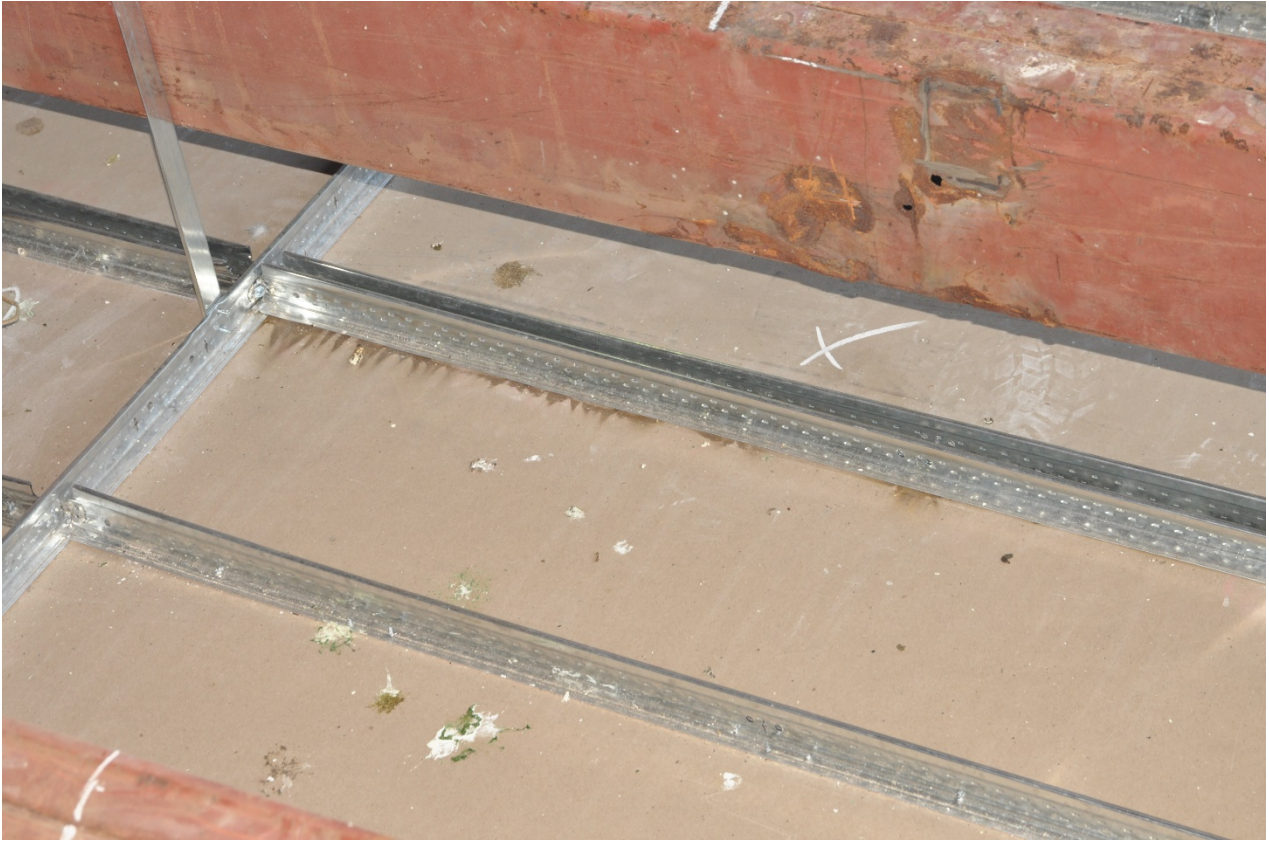
Figure 3.7: Discolouration visible (mid-section joint of specimen)

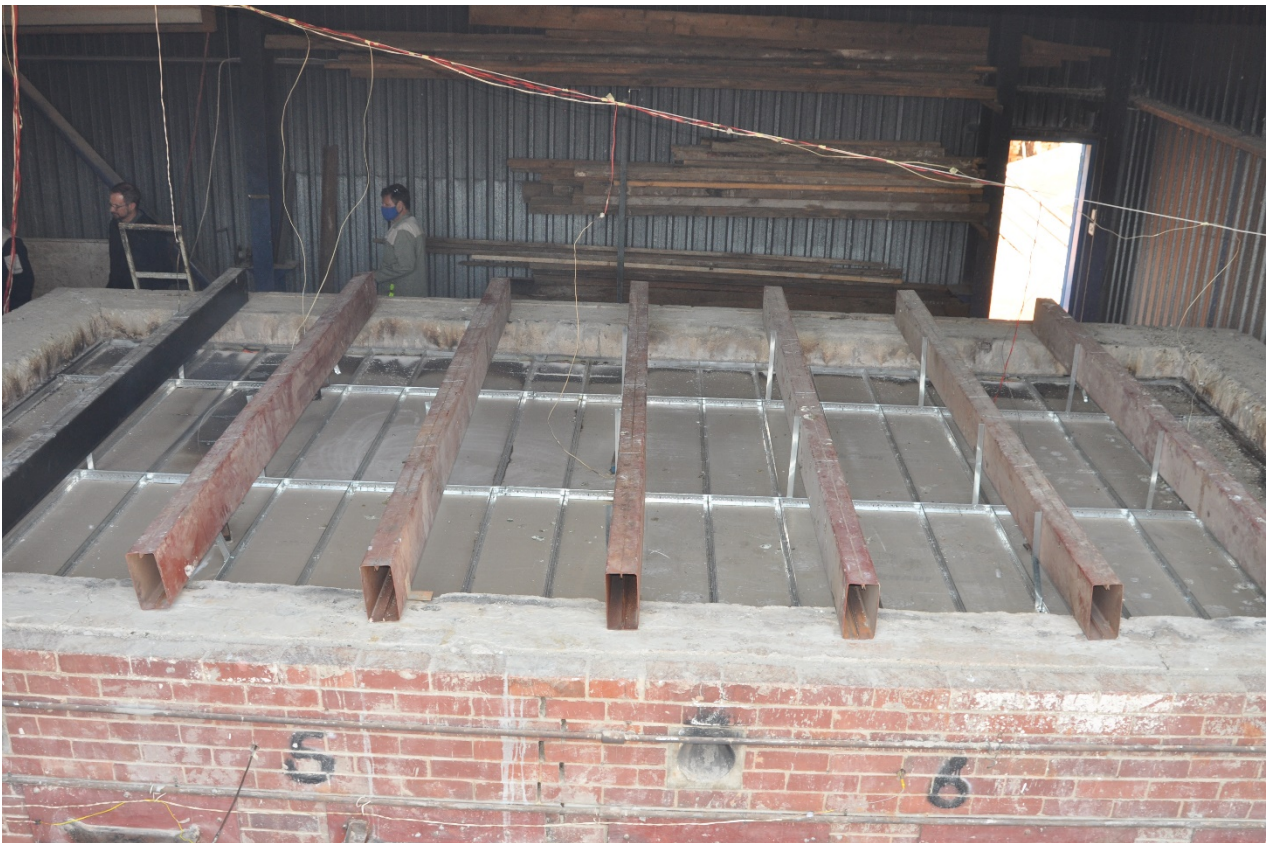
02:03:00	Hot spot near the middle measured to be approximately 185 °C
02:04:30	Large cracks formed in the middle between TC 4 & 5
02:05:00	– Test Concluded –

Figure 3.8: Unexposed side of specimen after conclusion of the test

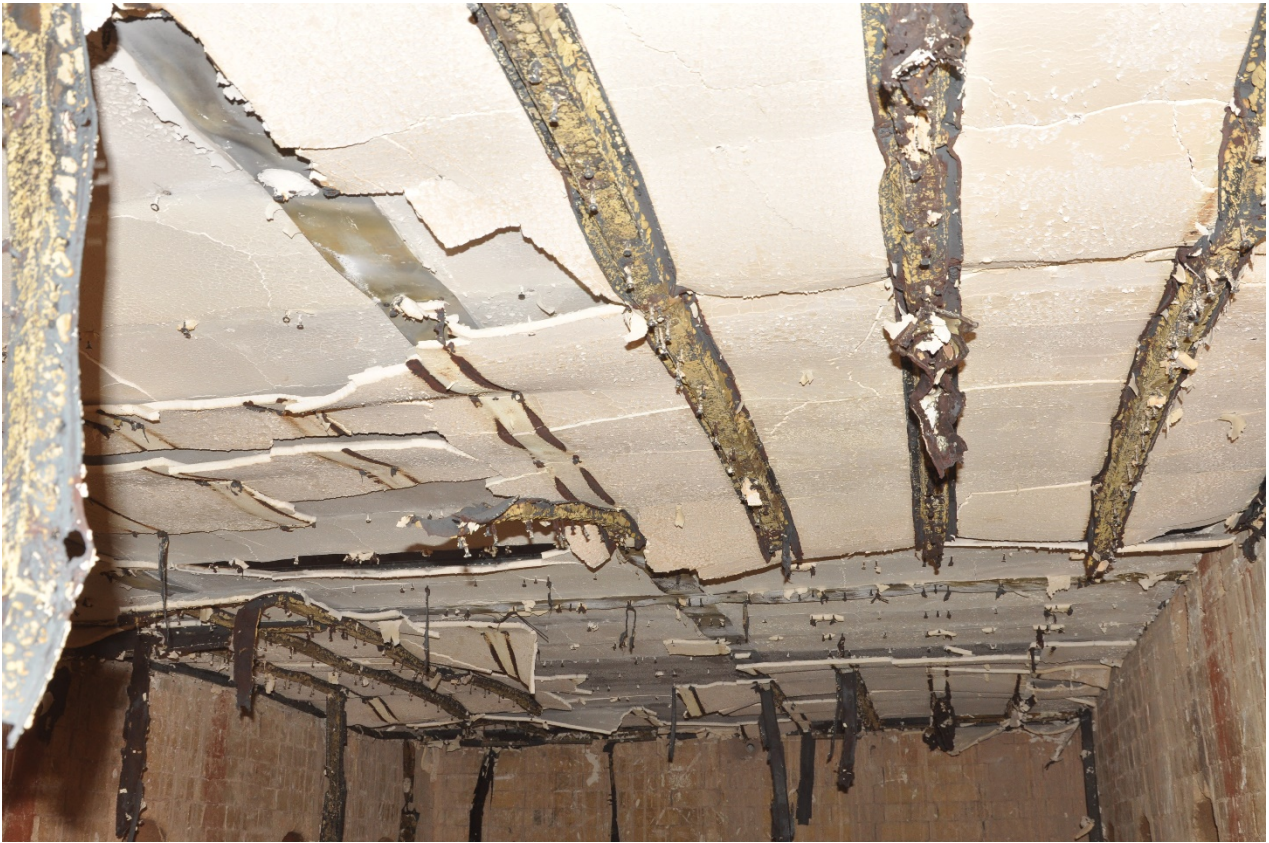
Figure 3.9: Exposed side of specimen after conclusion of the test
