TITLE	:	Report on the Large-scale Fire Resistance Properties of the non-load bearing CAPCO FireShield (400 mm stud spacing) partition wall system
REQUESTED BY	:	CAPCO (Pty) Ltd PO Box 4203 RIVERHORSE VALLEY EAST Durban 4017
CONTRACT No	:	FTC 20/110
ISSUE No	:	1
DATE	:	16 September 2020

This report classifies the Fire Resistance Properties of the **CAPCO FireShield (400 mm stud spacing)** partition wall system when tested and classified in accordance with the **SANS 10177 – 2** test protocol.

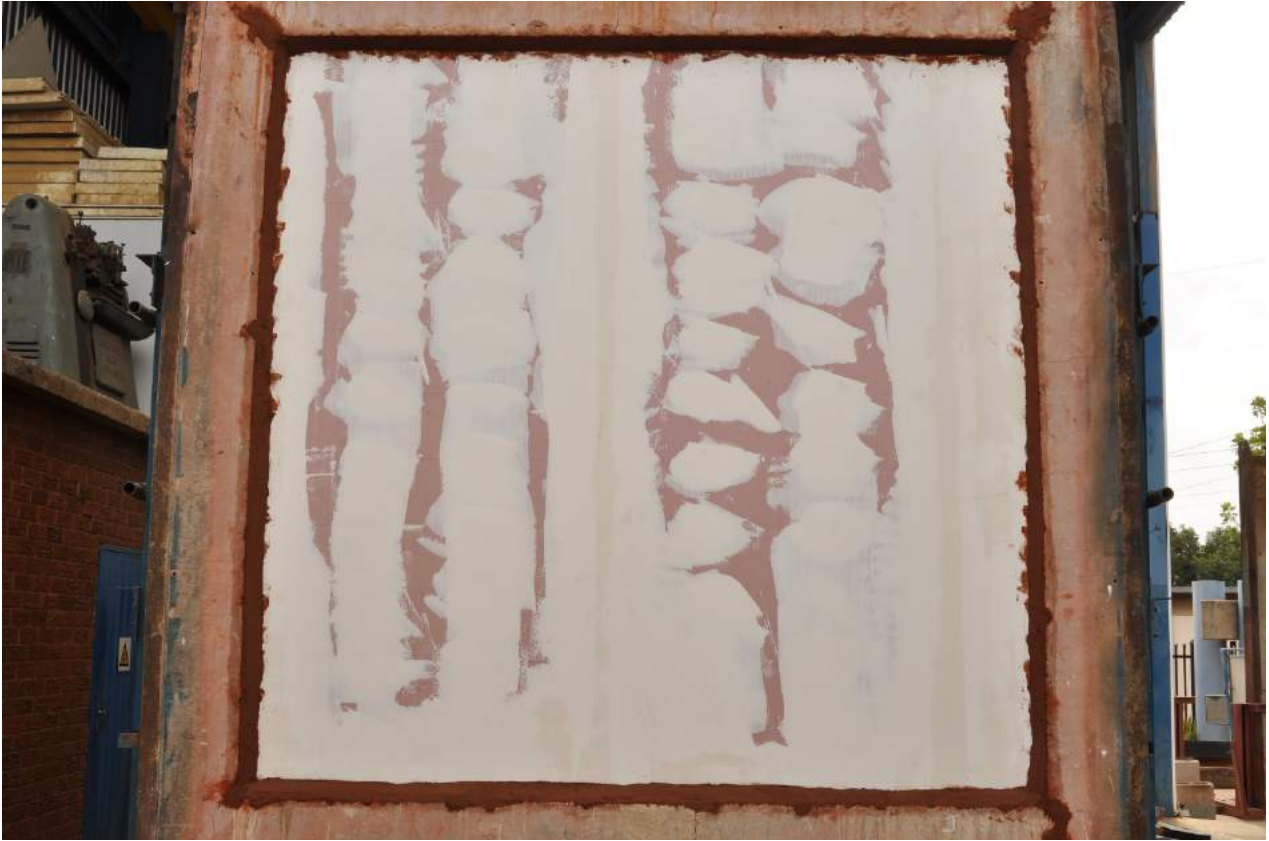
Figure 1.1: **FireShield (400 mm stud spacing)** system from the exposed side prior to the test

The test specimen is shown from the exposed and unexposed sides in Figures 1.1 and 1.2 prior to commencement of the test.

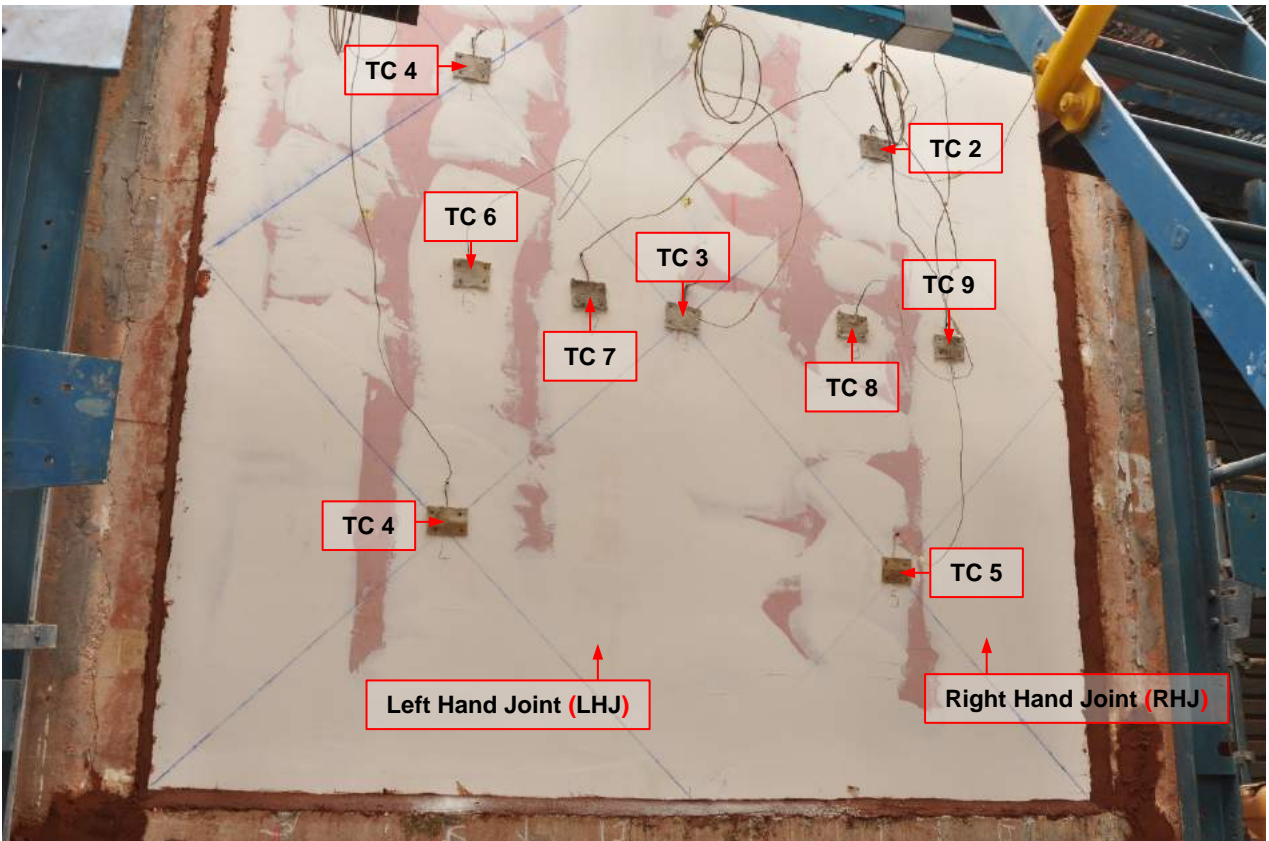
Figure 1.2: **FireShield (400 mm stud spacing)** system with thermocouples from the unexposed side

Insulation was measured using 5 thermocouples (TC 1 – TC 5) placed in a grid of equal area onto the surface of the specimen. An additional two thermocouples were used to measure the surface joints (TC 7 & TC 9). The positions of the thermocouples are shown in Figure 1.2.

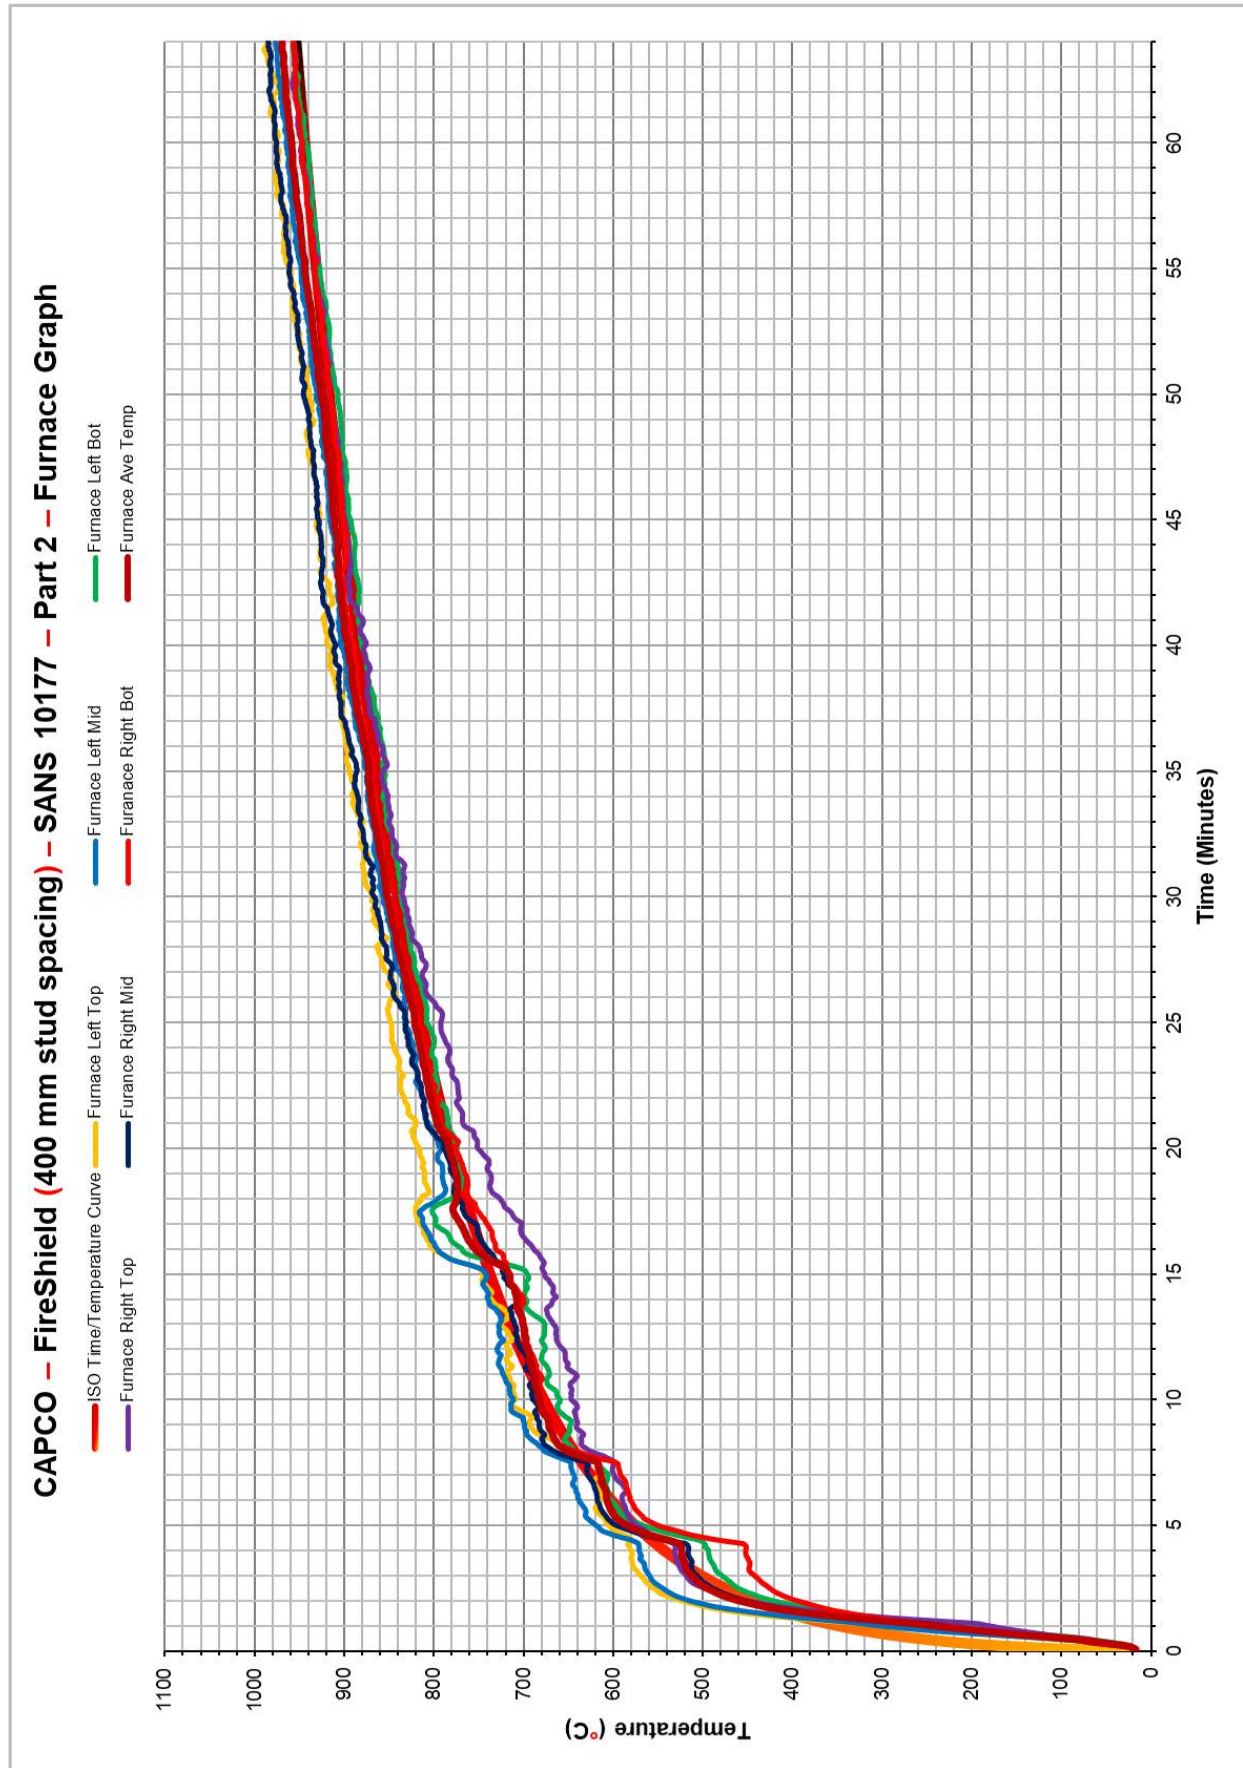
Figure 3.1: Furnace temperatures recorded during the large-scale FR test

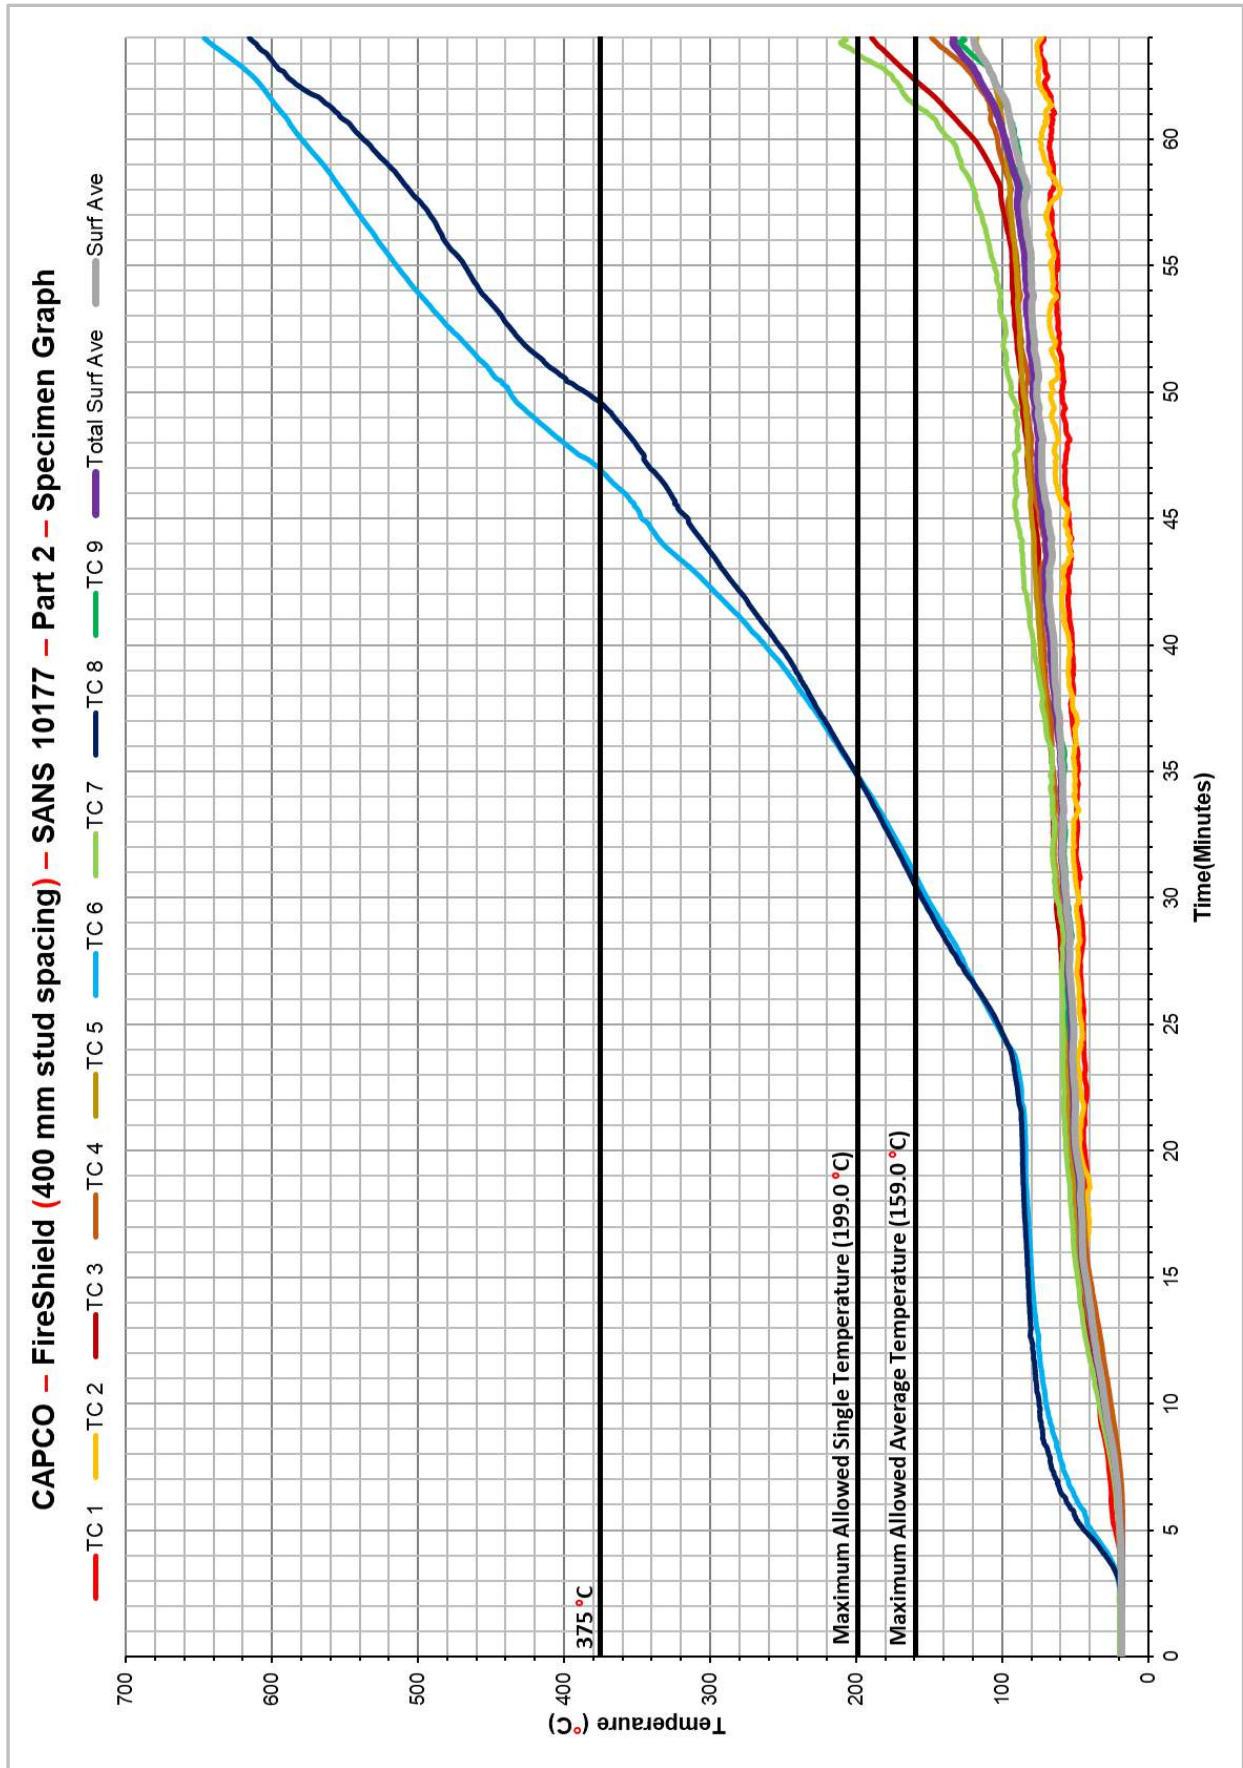
Figure 3.2: Temperatures recorded on the surface of the specimen

- 🔥 **Insulation (I):** TC 7 (left joint) exceeded the maximum single temperature allowed temperature at 63 minutes and 25 seconds.

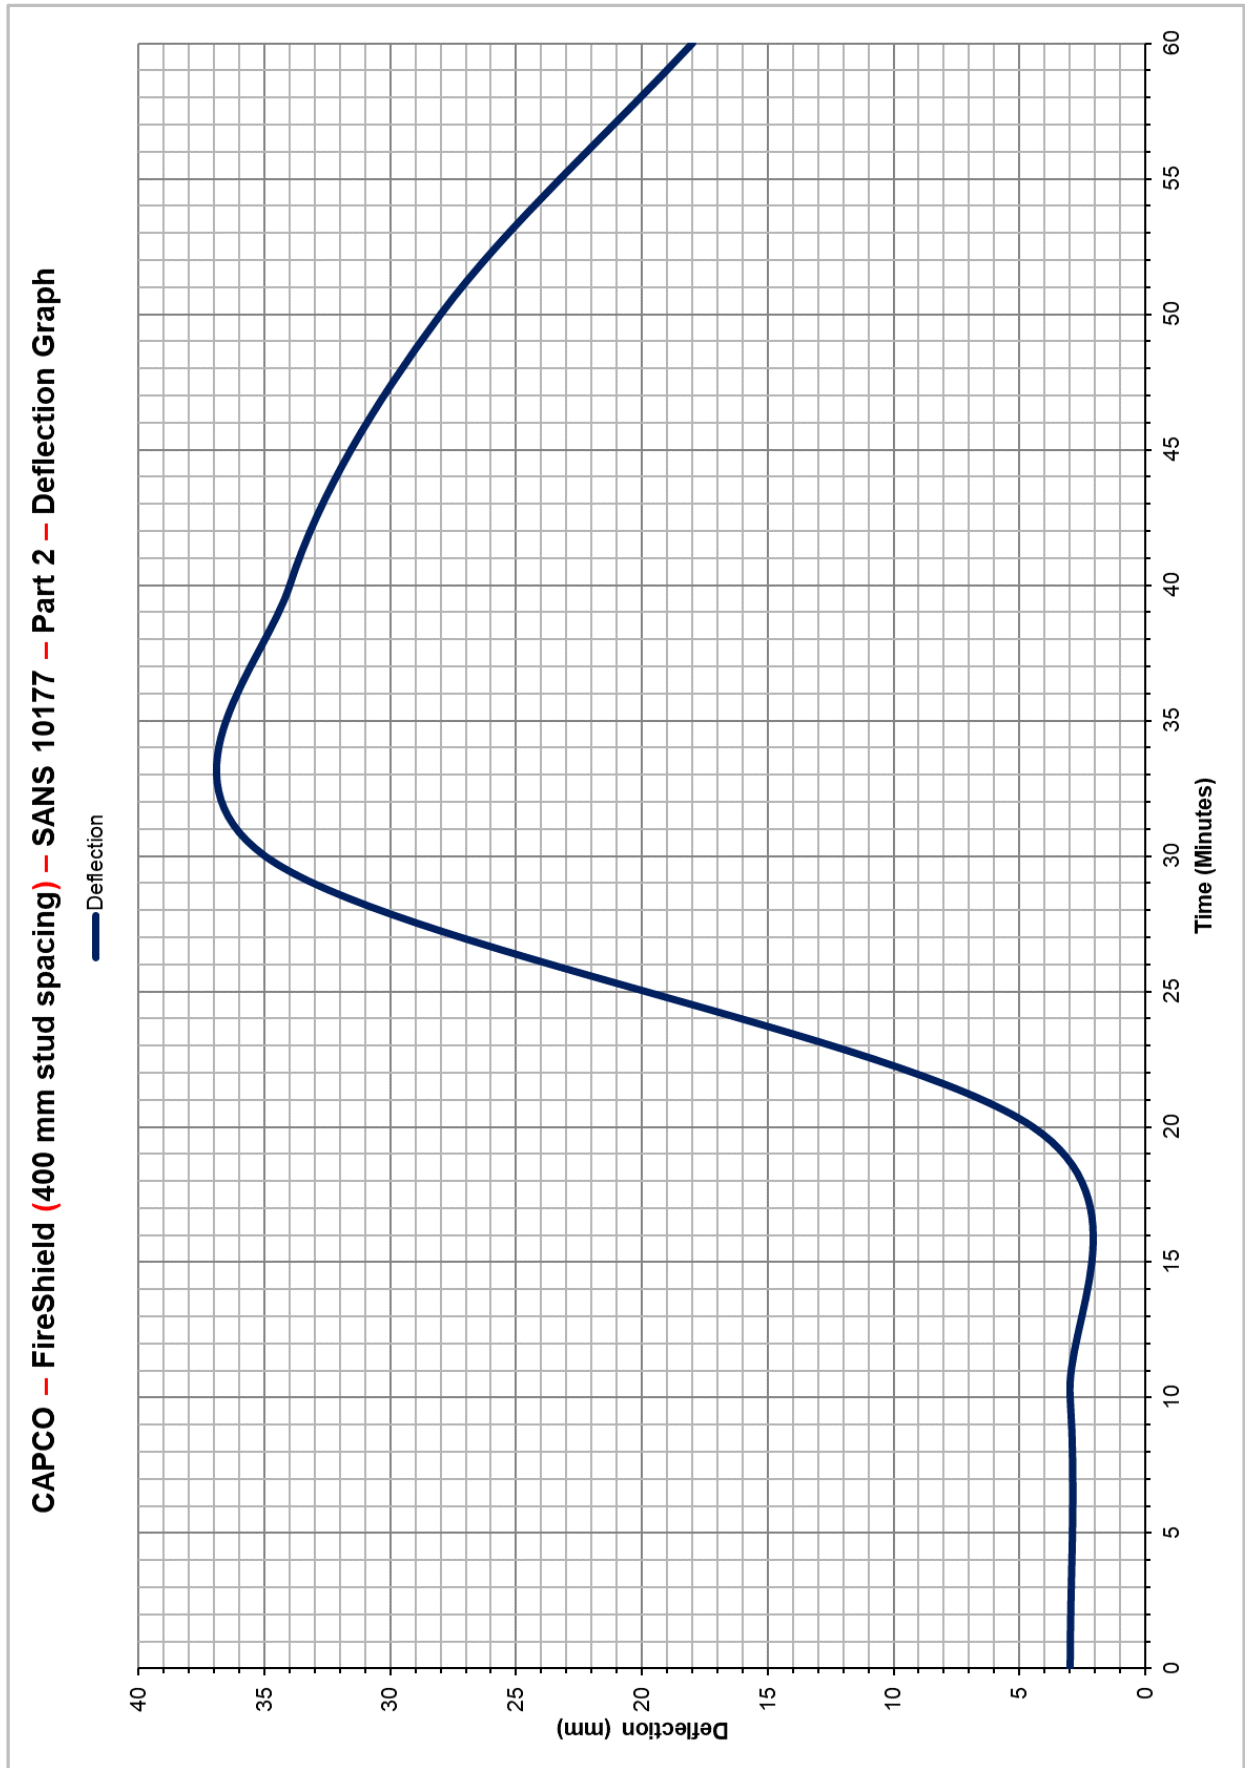
Figure 3.3: Deflection measured during the test

EVENT	TIME (hh:mm:ss)	DESCRIPTION
	00:00:00	– Test Started – 3 mm
1	00:10:00	Deflection » 3 mm
2	00:20:00	Deflection » 4.5 mm
3	00:30:00	Deflection » 35 mm
4	00:40:00	Deflection » 34 mm
5	00:50:00	Deflection » 28 mm
6	01:00:00	Deflection » 18 mm
	01:04:00	– Test Concluded –

- 🔥 **Stability (R):** Stud temperatures reached 375 °C at approximately 47 minutes. Maximum deflection measured was 35 mm at 30 minutes which does not exceed the Neutral Axis.

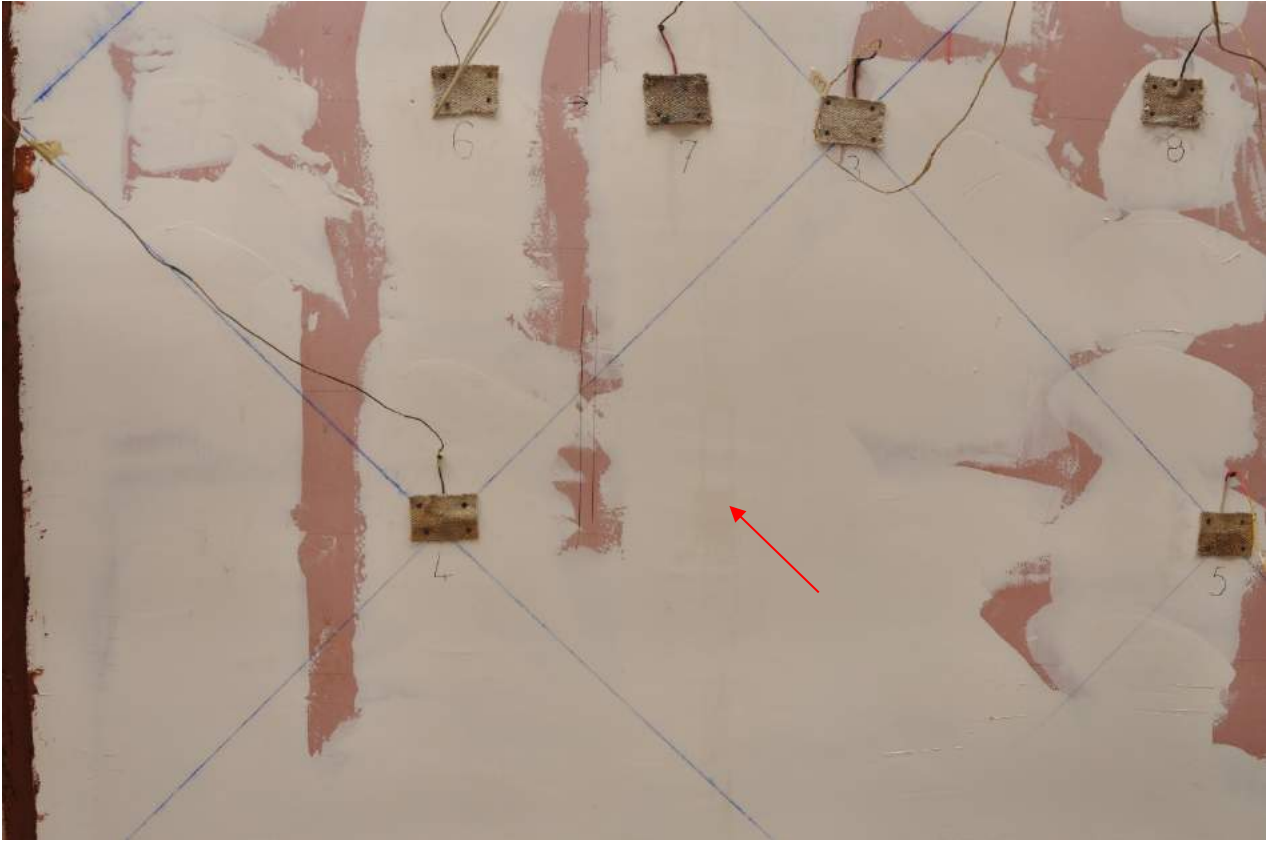
Figure 3.4: Slight discolouration on LHH

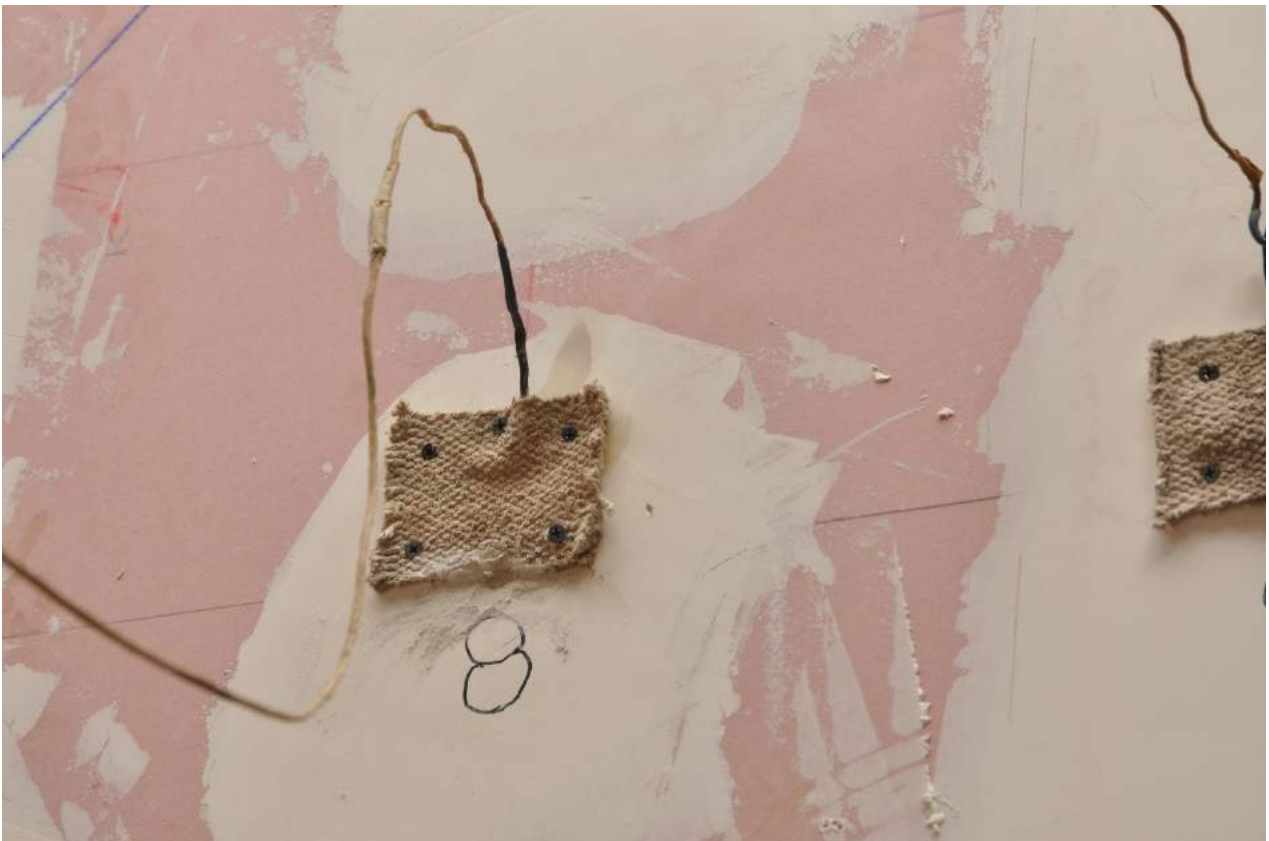
Figure 3.5: Steam release from TC 8 (stud thermocouple)

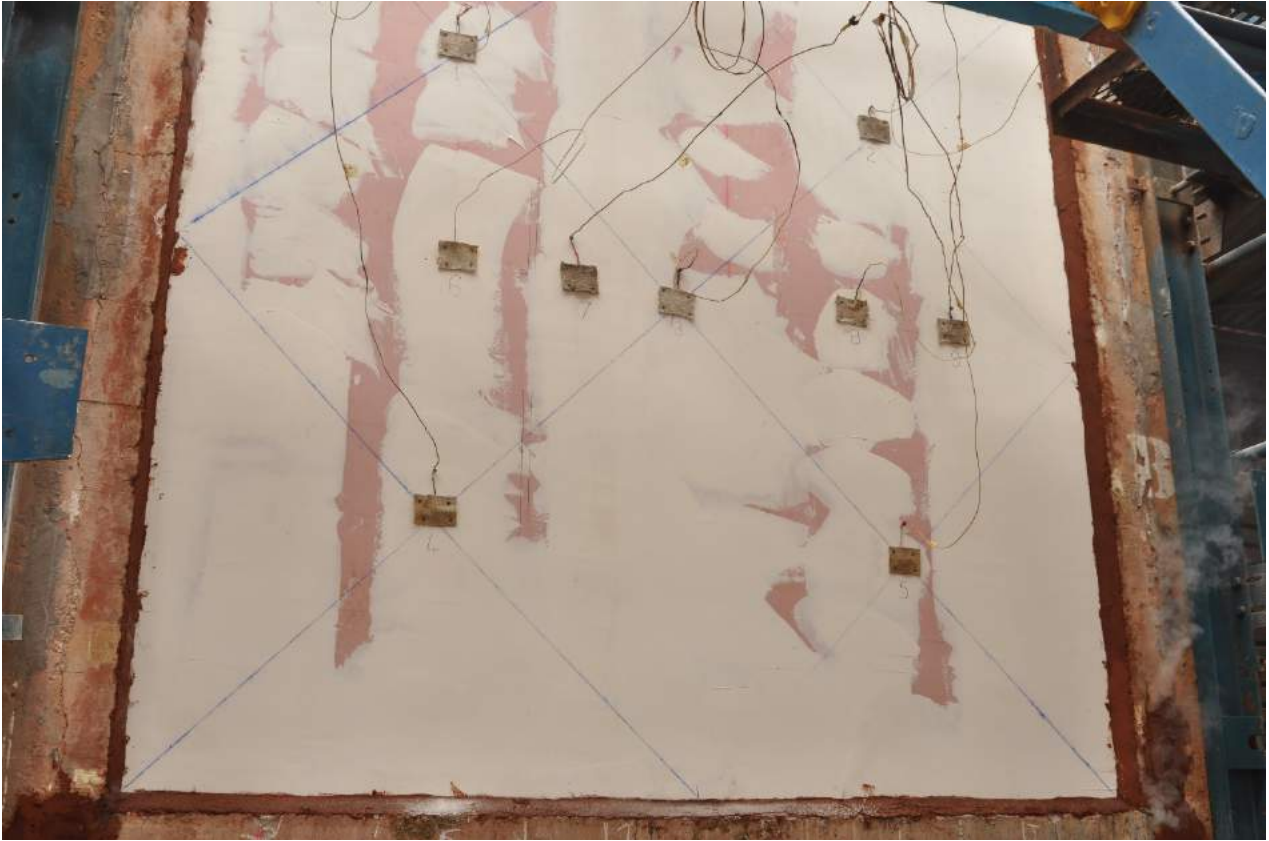
Figure 3.6: Approximately 30 minutes

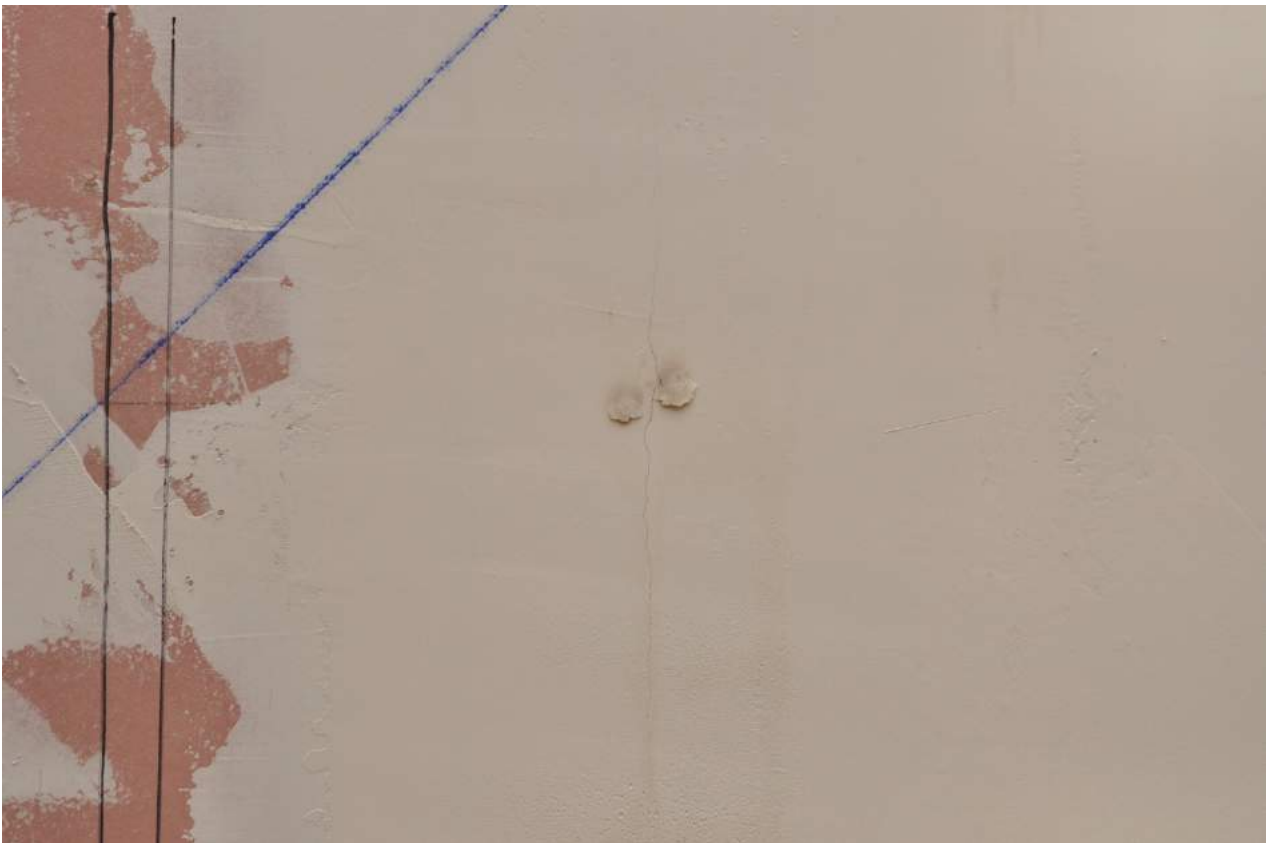
Figure 3.7: Crack forming and screw discolour on LHJ

- 🔥 **Integrity (E):** Cracks formed on both joints, however no straight through gaps were noted.

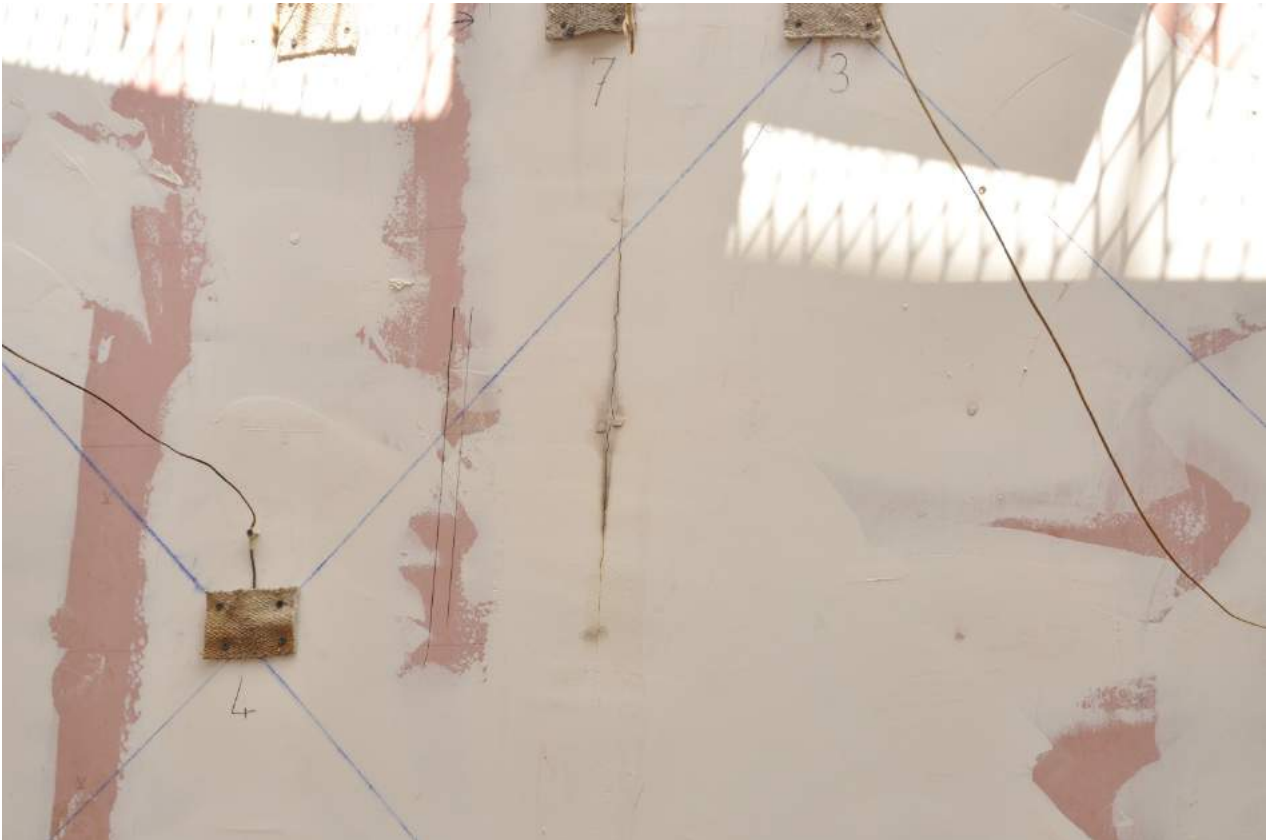
Figure 3.8: Crack discolour on LHJ

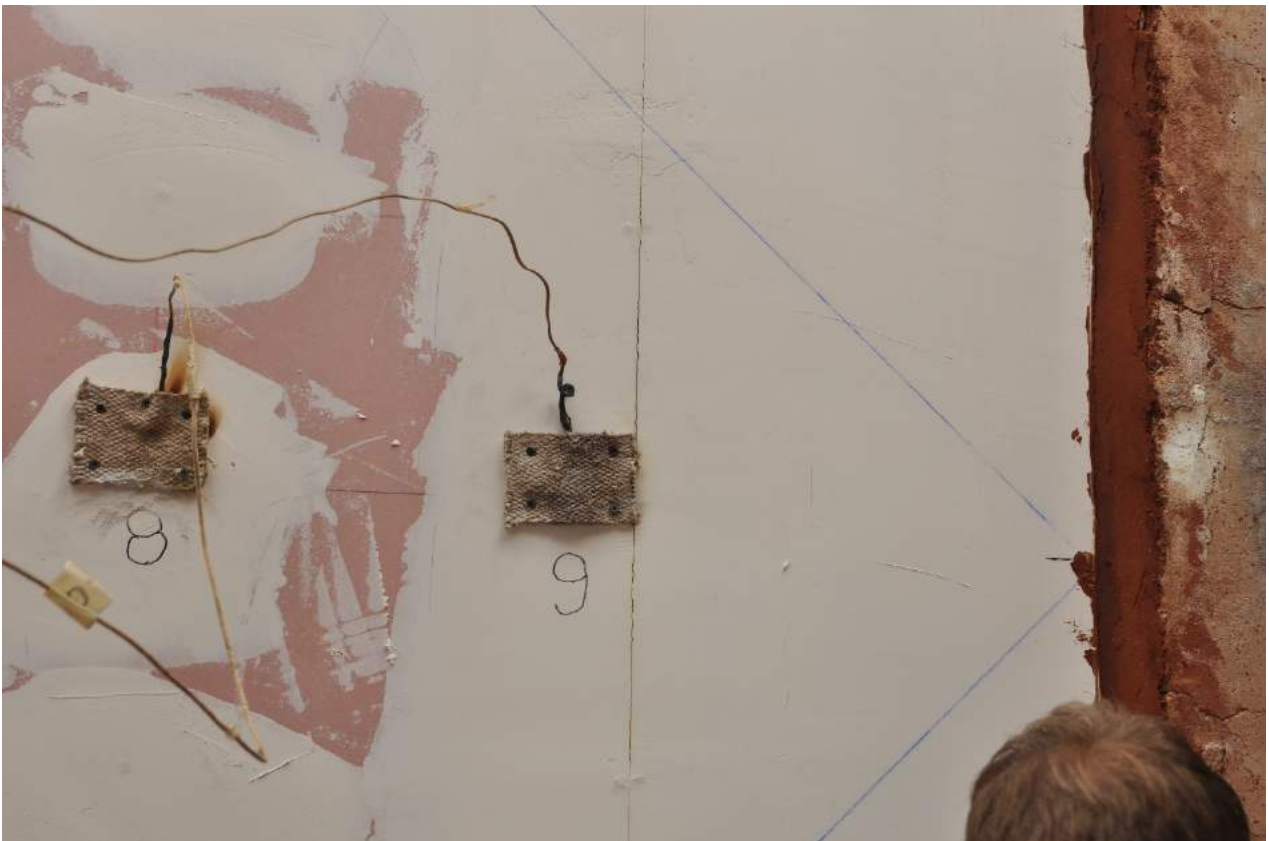
Figure 3.9: Crack forming and discolour on RHJ

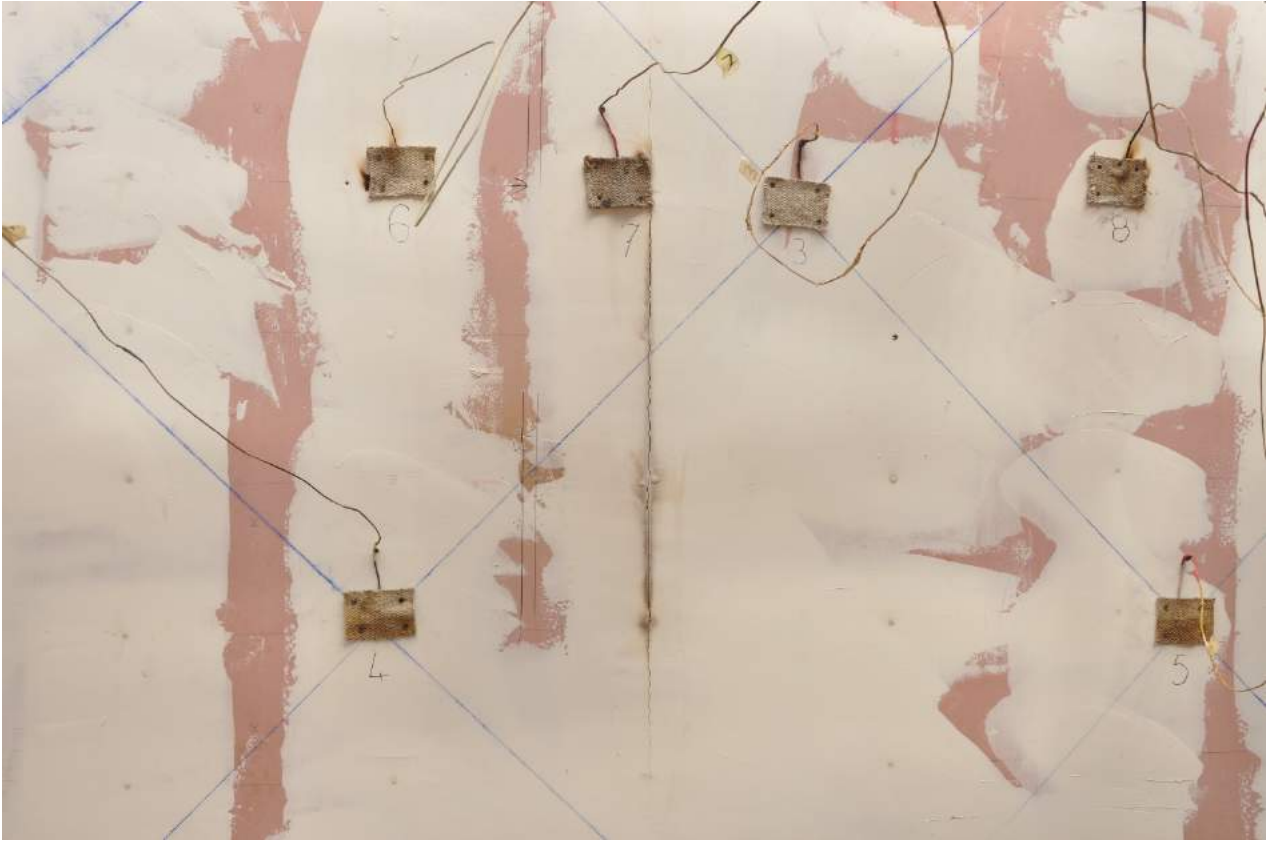
Figure 3.10: Crack propagate

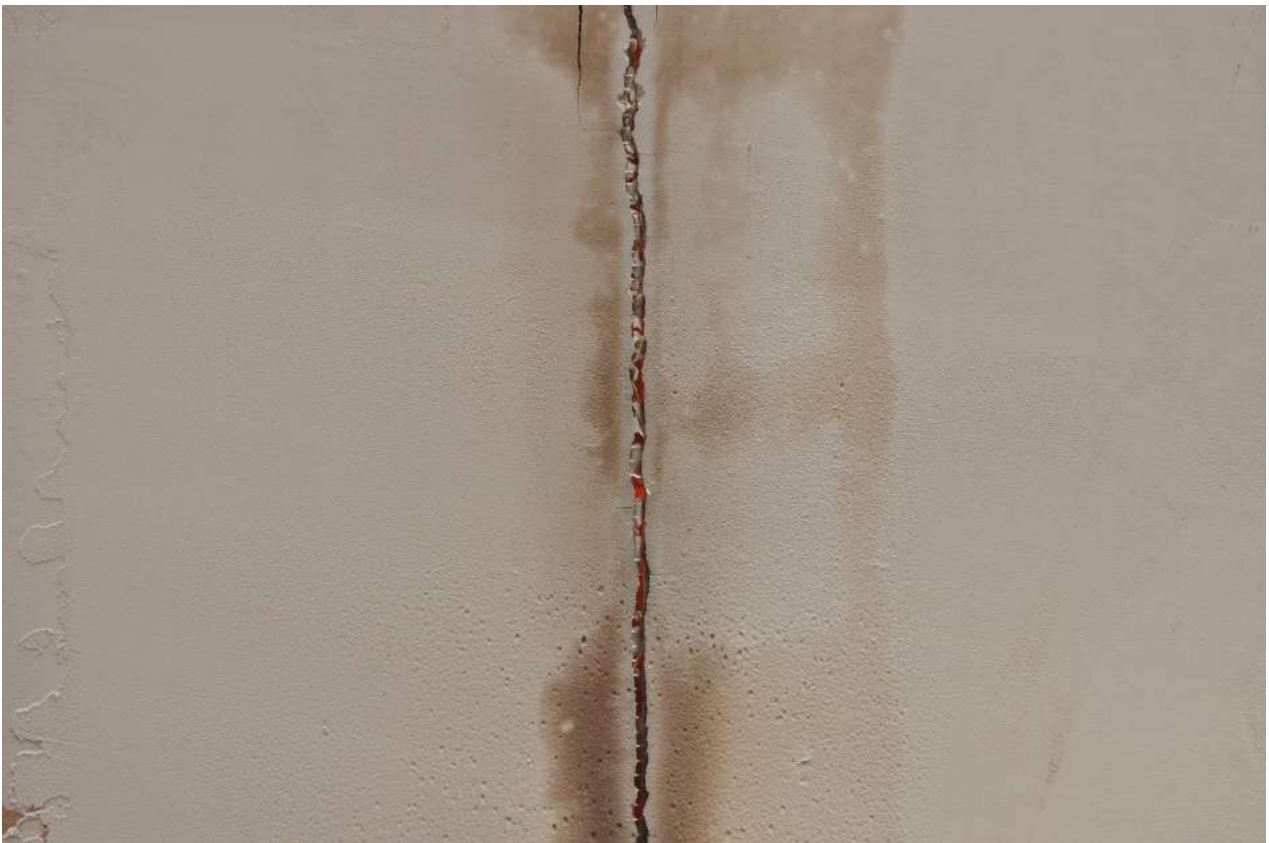
Figure 3.11: Glowing visible on LHJ

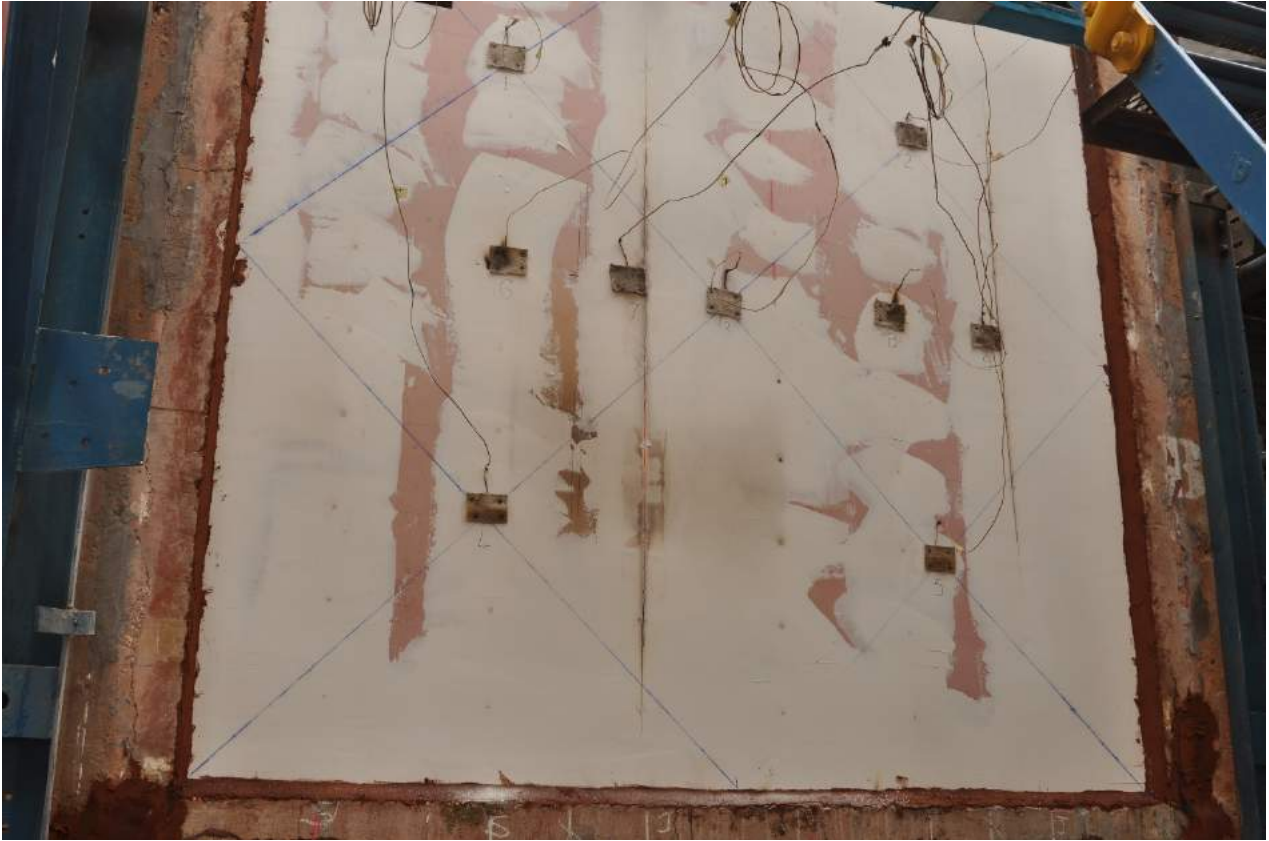
Figure 3.12: Condition of specimen shortly before the test was stopped

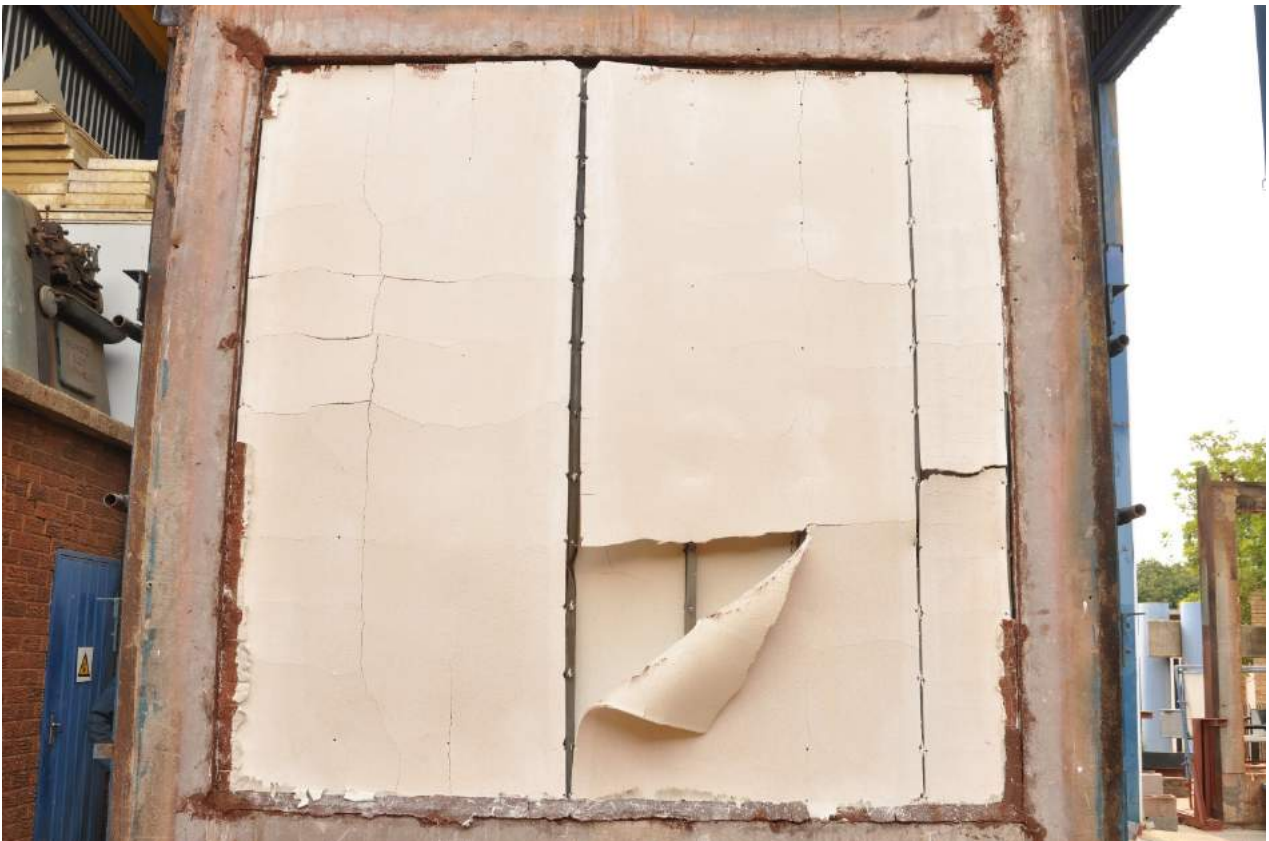
Figure 3.13: Exposed side of specimen wall after removal from **SANS 10177 – 2** facility

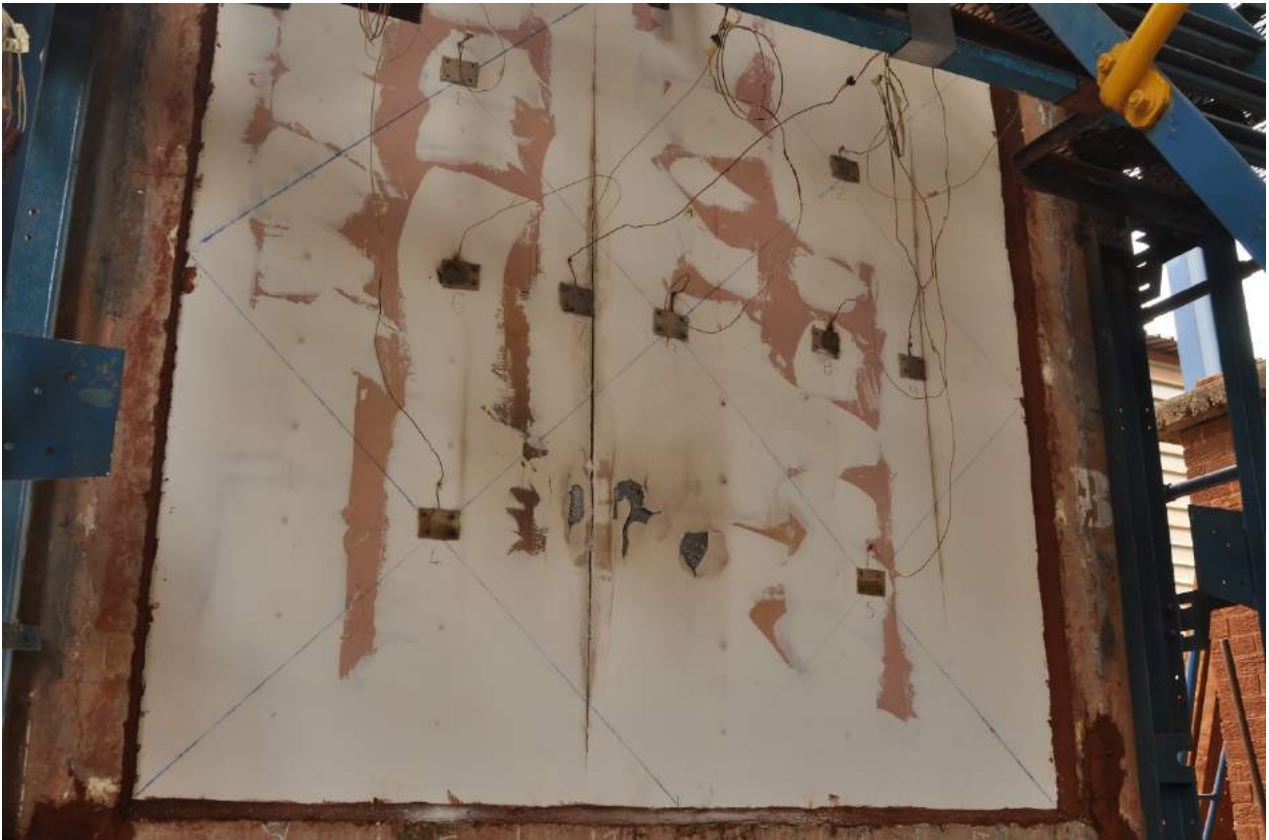
Figure 3.14: Unexposed side of specimen wall after removal from **SANS 10177 – 2** facility

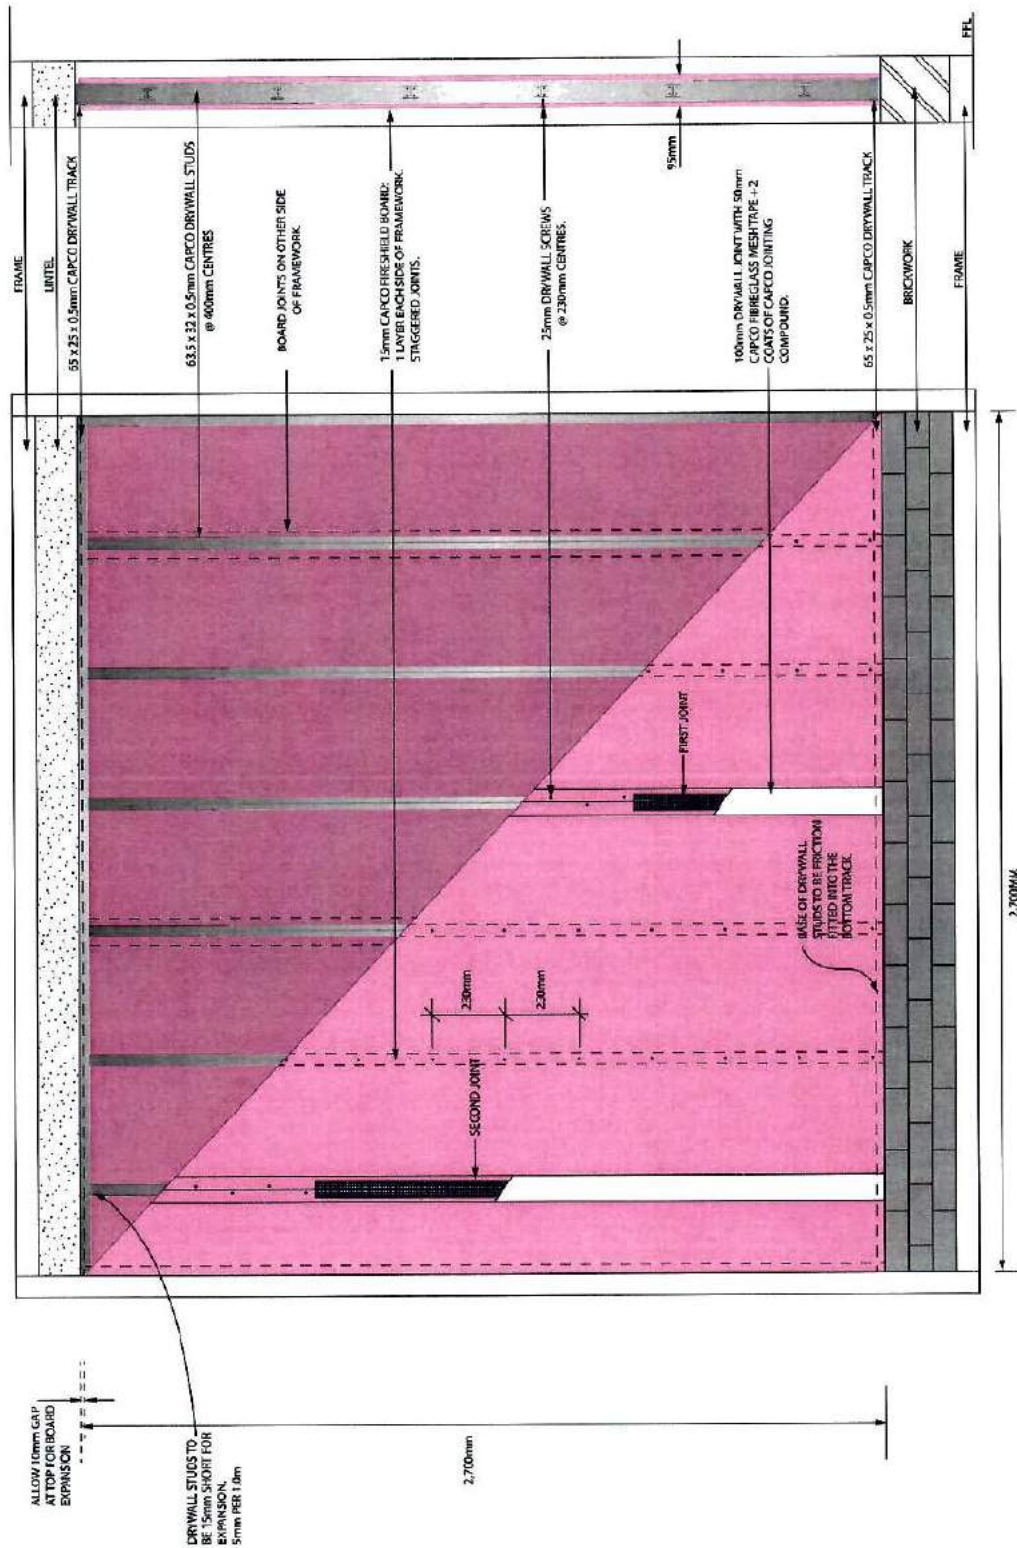
**60MIN FIRE TEST: 1 LAYER OF 15MM FIRESHIELD
GYPSUM BOARD EACH SIDE**
